# Dam Safety Inspection Report

Name: **Indian Brook Reservoir Dam**  
State ID: **69.01** NID ID: **VT00055**  
Hazard Class: **High Hazard Potential**

Town: **Essex**  
Watershed: **Malletts Bay**  
Stream: **Indian Brook**

**Inspection type:** Periodic

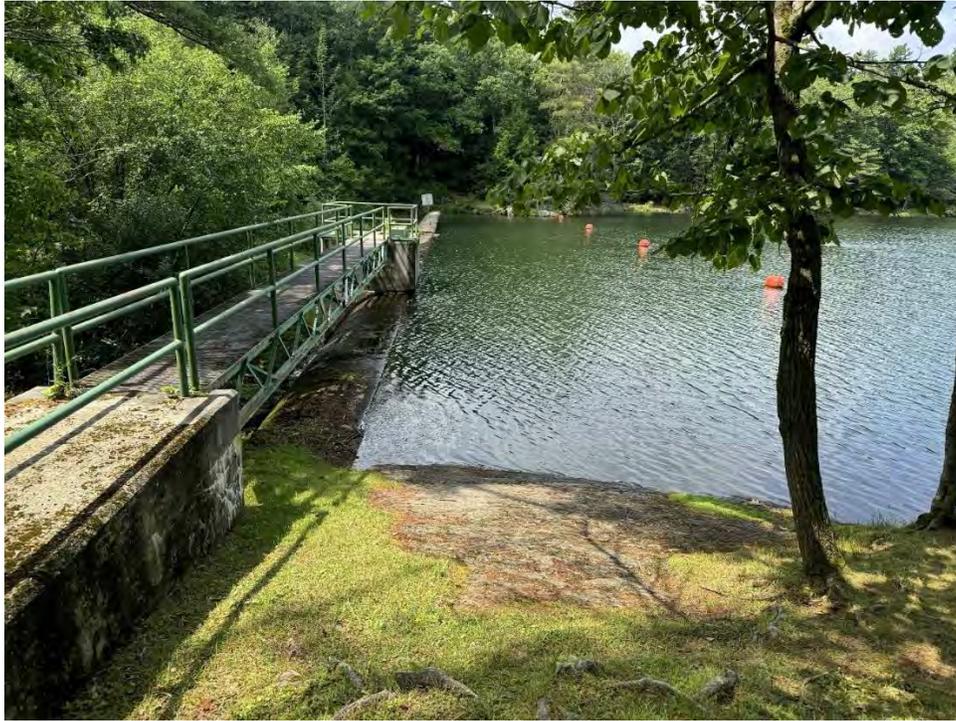
Looking at the crest from the left abutment. Upstream wall is submerged.

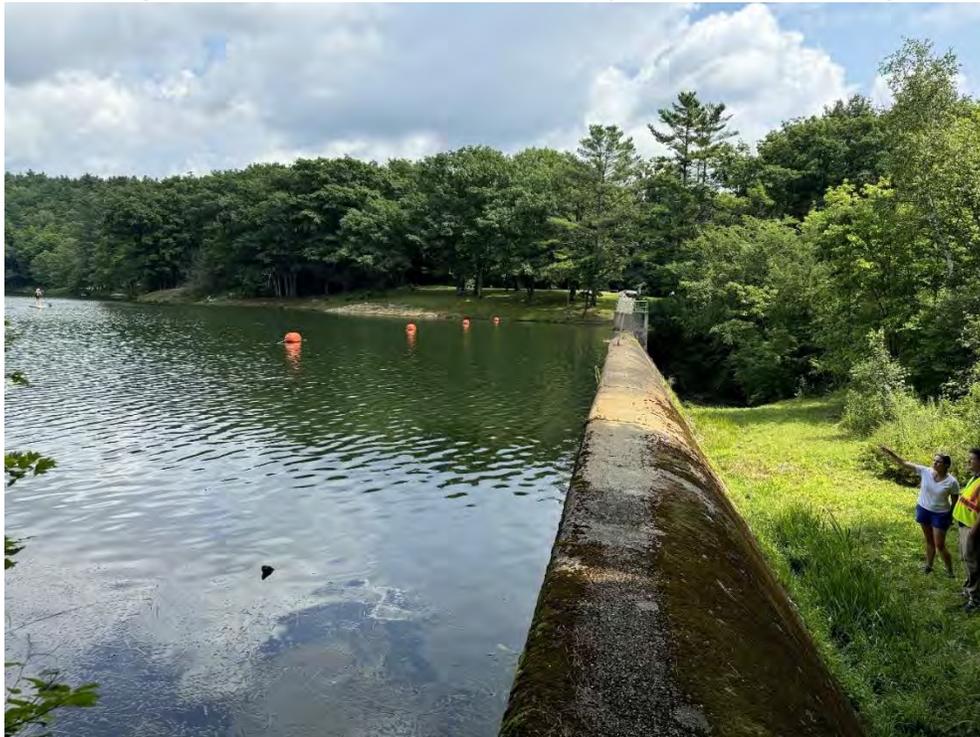
Looking at the crest from the right abutment.

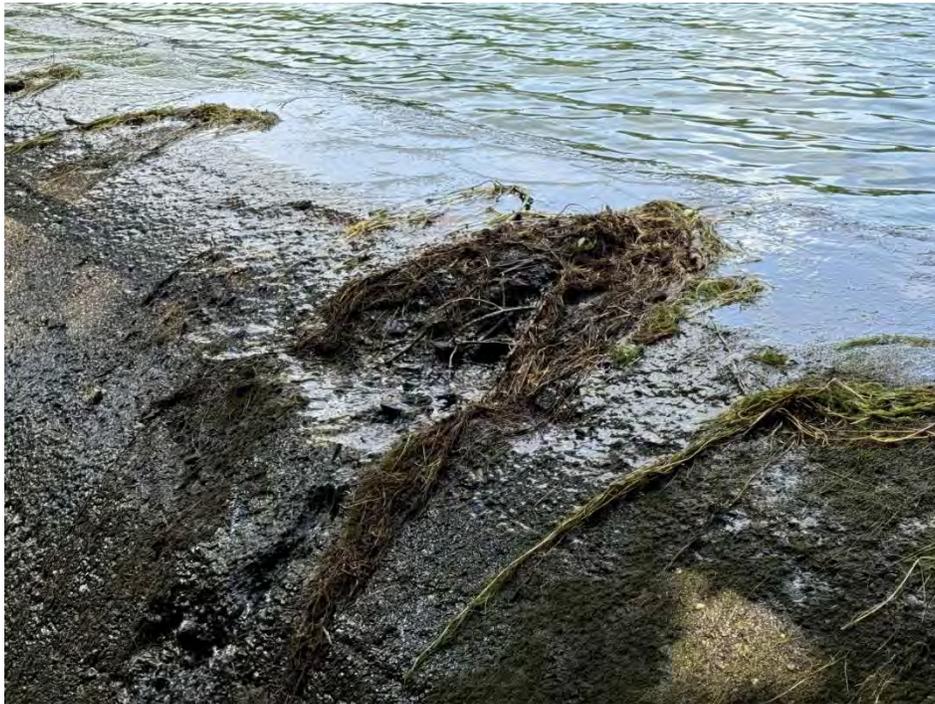
Crest issues	Action
<b>Concrete deterioration</b>	<input type="checkbox"/> None <input checked="" type="checkbox"/> Monitor <input checked="" type="checkbox"/> Maintenance <input type="checkbox"/> Engineer

Example concrete crest deterioration below gate chamber bridge.

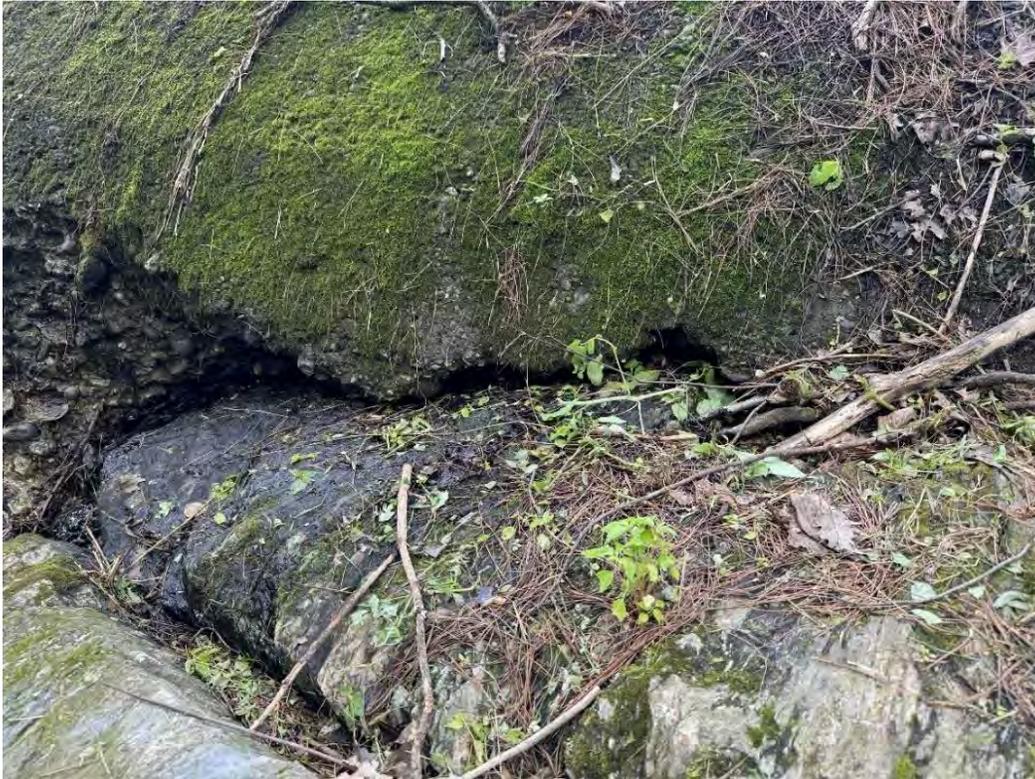
Principal spillway issues	Action
<b>Deteriorating Concrete</b>	
<ul style="list-style-type: none"> <li>• Deterioration of concrete at contact with rock at left abutment (downstream face).</li> <li>• Concrete deterioration along the downstream face of the horizontal lift joint and the principal spillway crest.</li> <li>• Spalling at the horizontal construction lift joints of the downstream principal spillway face.</li> <li>• Spalling present with iron-stained seepage at the rock contact with the toe of the principal spillway.</li> <li>• Prominent horizontal construction joint with spalled joint faces, approximately 15 feet below the crest; the deteriorated joint extends the majority of the length of the principal spillway.</li> <li>• Minor missing grout between the downstream spillway face joint to the low-level outlet structure.</li> <li>• Efflorescence observed below gate chamber (downstream face).</li> <li>• Vegetation growth is present throughout the downstream face and crest.</li> </ul> <p>Comments: Minor issues can be addressed through maintenance while significant spalling and joint deterioration will require repair developed in coordination with a licensed professional engineer.</p>	<ul style="list-style-type: none"> <li><input type="checkbox"/> None</li> <li><input checked="" type="checkbox"/> Monitor</li> <li><input checked="" type="checkbox"/> Maintenance</li> <li><input checked="" type="checkbox"/> Engineer</li> </ul>

Concrete deterioration on left side of principal spillway at left abutment contact (downstream face).

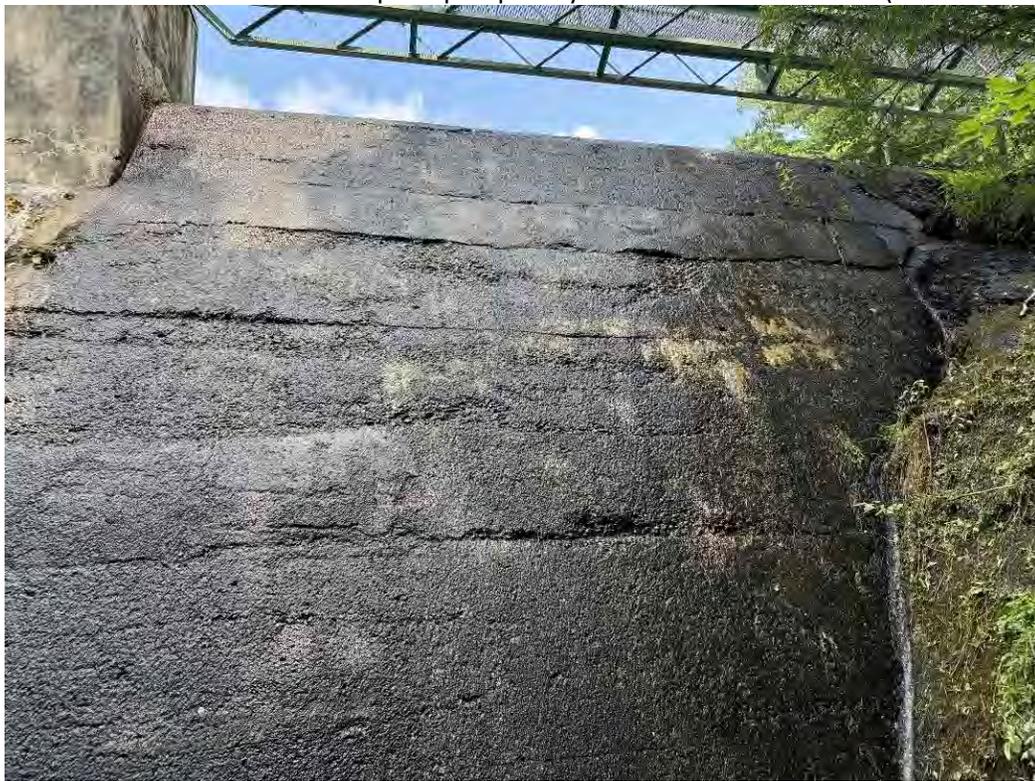
Left side of principal spillway at left abutment contact.

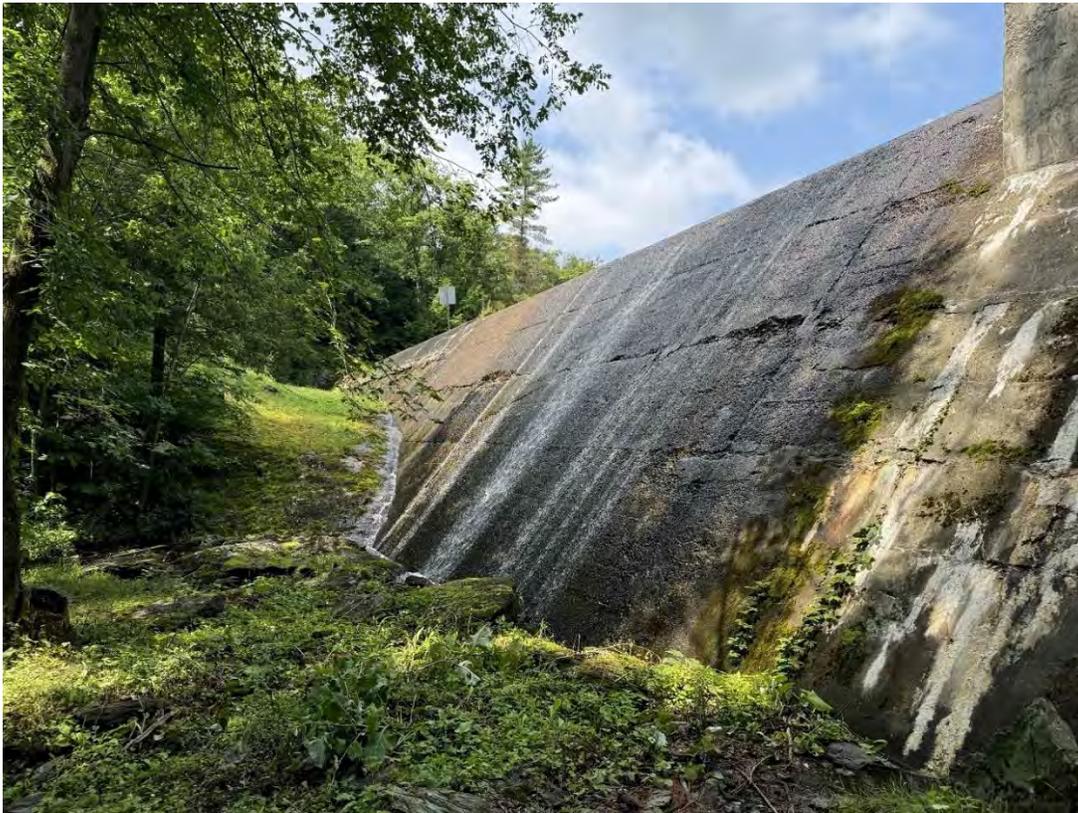
Right side of principal spillway, note efflorescence below gate chamber.

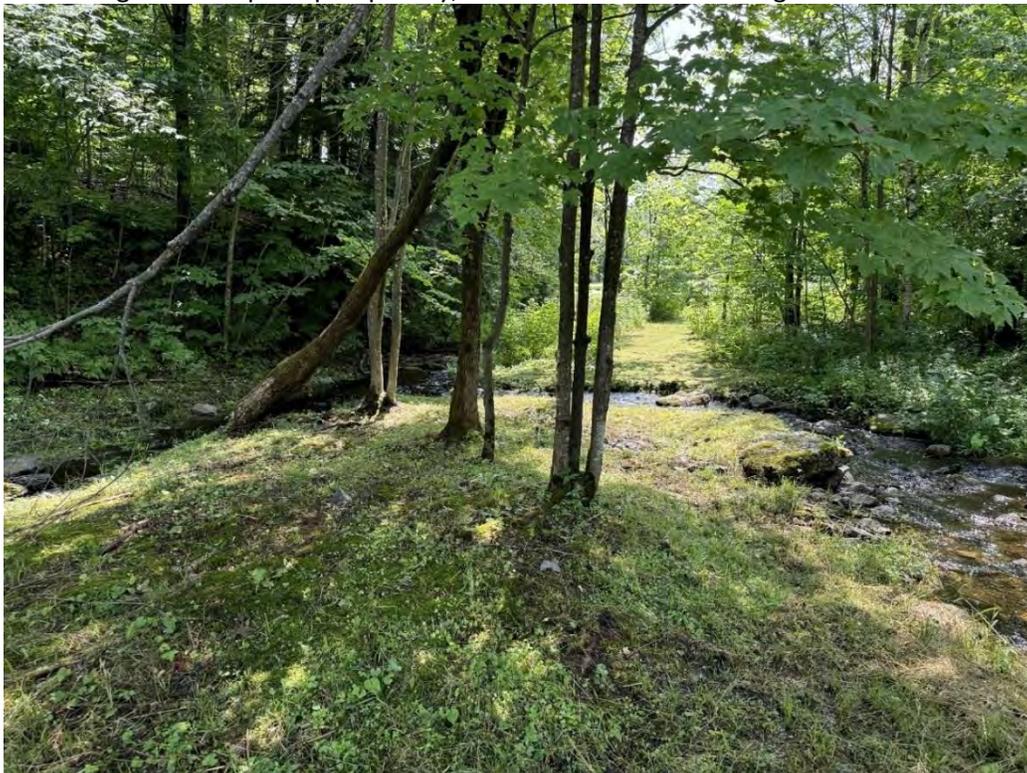
Outlet channel below dam.

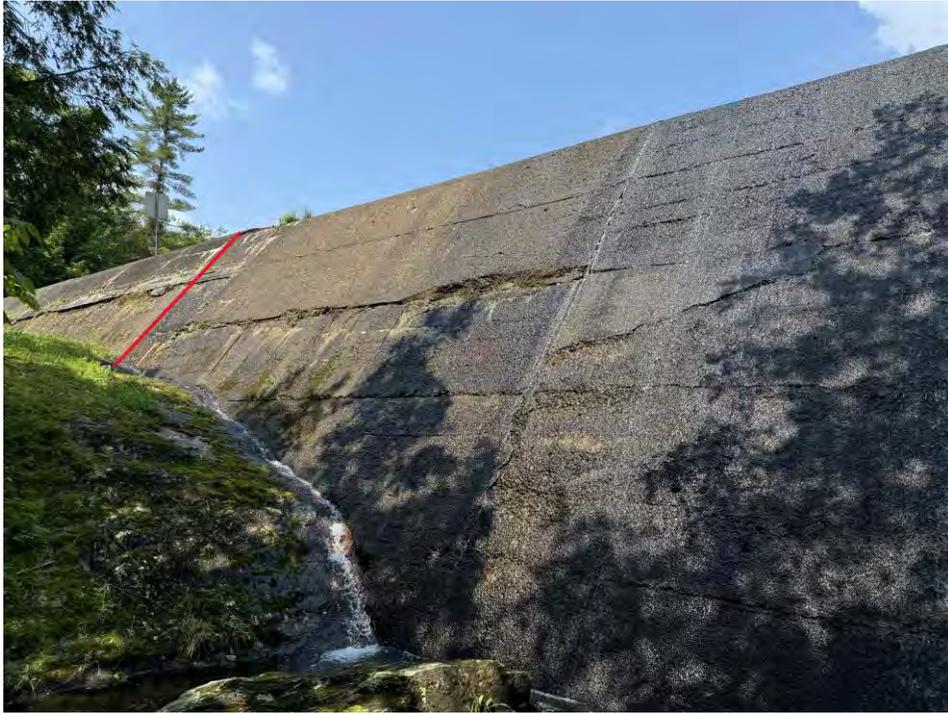
Auxiliary spillway issues	Action
<b>Deteriorating concrete</b>  Seepage/leakage along toe, minor boil historically noted in this area. Iron staining present.  Deterioration of previous 2003 repair/patch work.  Leakage emanating from construction joints and below 2003 repair/patch work.  Vegetation growth is present throughout the spillway downstream face and joints.  Comments: Minor issues can be addressed through maintenance while significant spalling and joint deterioration will require repair developed in coordination with a licensed professional engineer.	<input type="checkbox"/> None <input checked="" type="checkbox"/> Monitor <input checked="" type="checkbox"/> Maintenance <input checked="" type="checkbox"/> Engineer

The red line illustrates the breakpoint between principal and auxiliary spillway. Note there is significant seepage and leakage flowing along interface of bedrock with concrete and spilling down into discharge channel below dam.

<i>Geotechnical/Geologic</i>	<ul style="list-style-type: none"> <li>Perform additional investigation and analysis to determine the source and potential risks of the uncontrolled seepage and leakage.</li> <li>Perform subsurface investigation and testing to determine foundation conditions at the dam as it relates to the stability of the dam, and the ability of the dam to safely withstand overtopping.</li> </ul>
<i>Hydrology and hydraulics/hazard classification</i>	<ul style="list-style-type: none"> <li>Refine the GZA 2023 H&amp;H analysis using updated survey information referenced in above Survey &amp; Bathymetry section. Verify the dam has adequate freeboard during the inflow design flood.</li> <li>Evaluate the erodibility of the rock at the downstream toe as it relates to the stability of the dam (utilize information collected in the above Geotechnical and Geologic section).</li> <li>Identify alternatives as required to make the dam hydraulically adequate or capable of safely being overtopped during the Inflow Design Flood.</li> <li>Evaluate the hydraulic capacity of the low-level-outlet and its suitability to drawdown the pond in an emergency.</li> </ul>

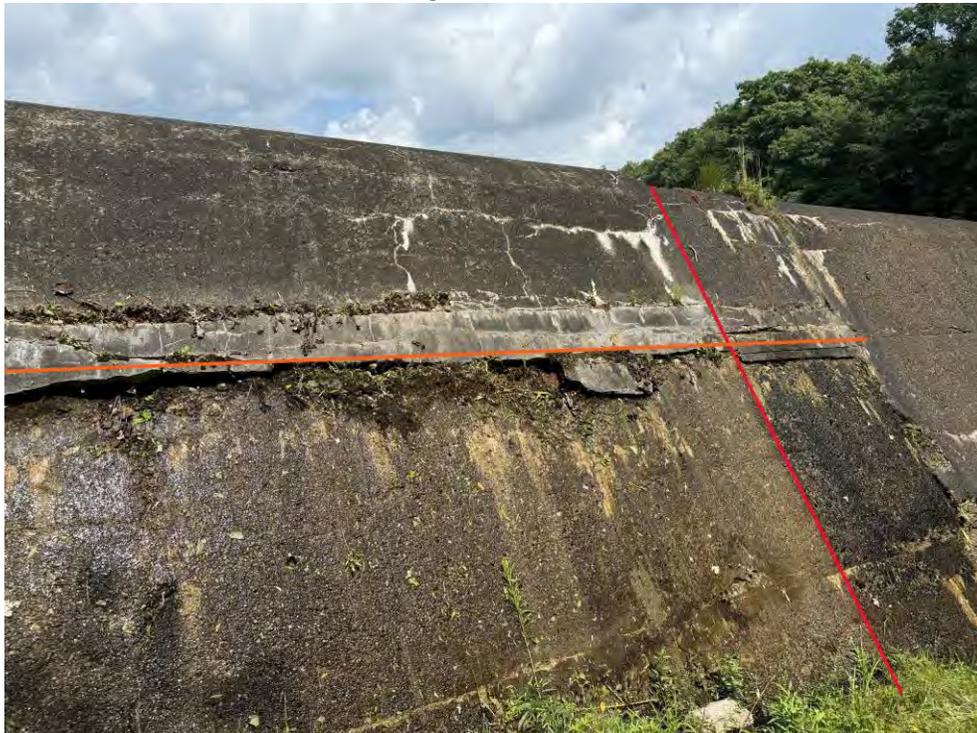
The red vertical line illustrates the breakpoint between principal and auxiliary spillway. Orange horizontal line illustrates 2003 repair surface breakpoint.

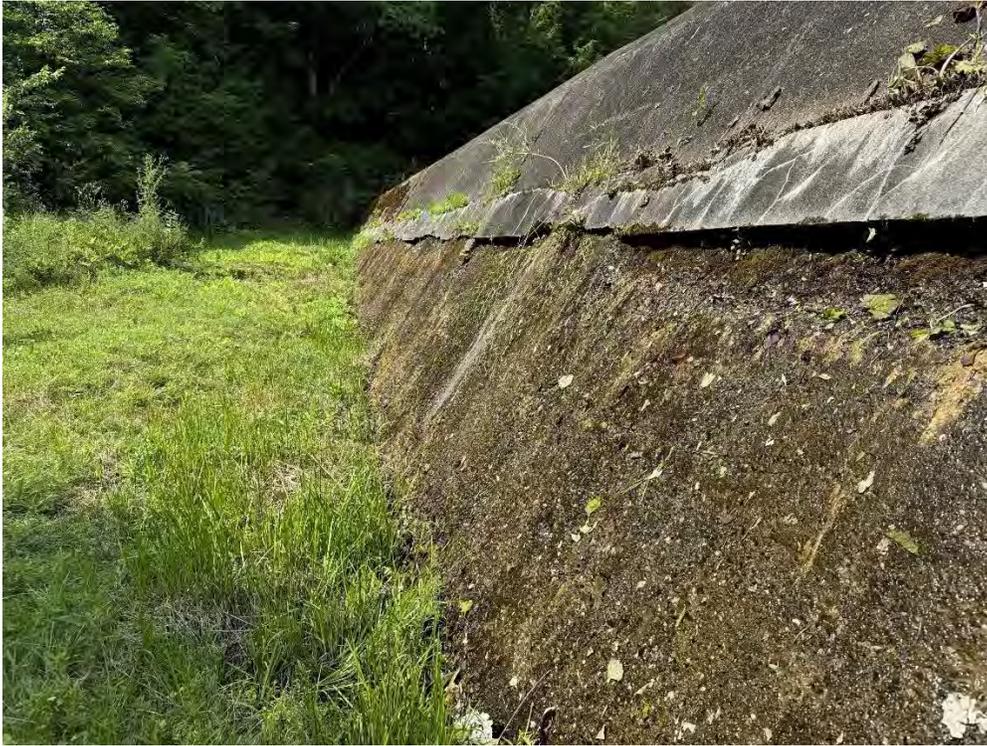
Looking towards the right abutment, note leakage from beneath 2003 repair surface (wetted concrete surface despite no overflow).

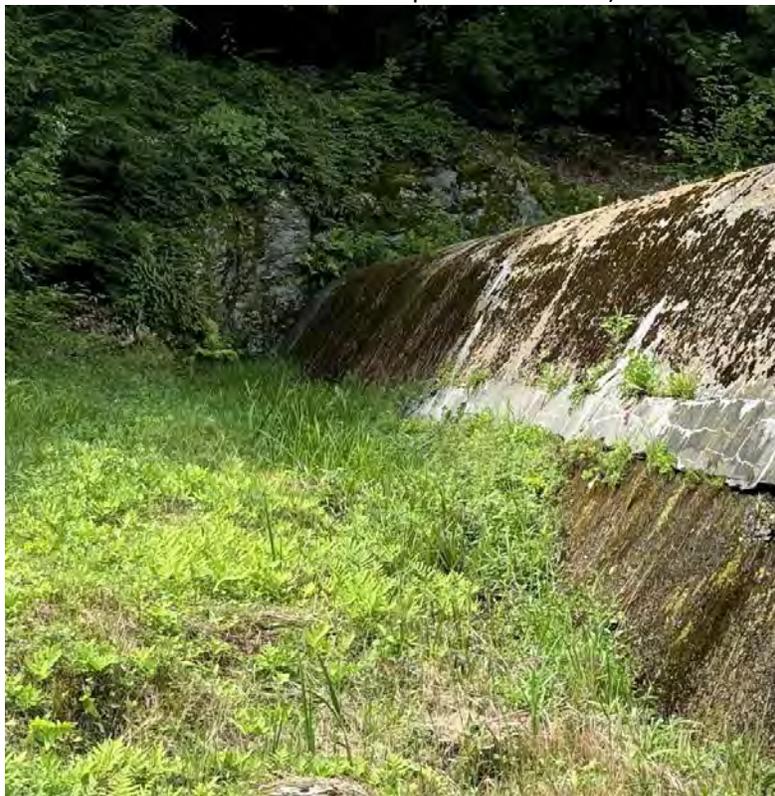
The auxiliary spillway crest contacts right dam abutment (rock).

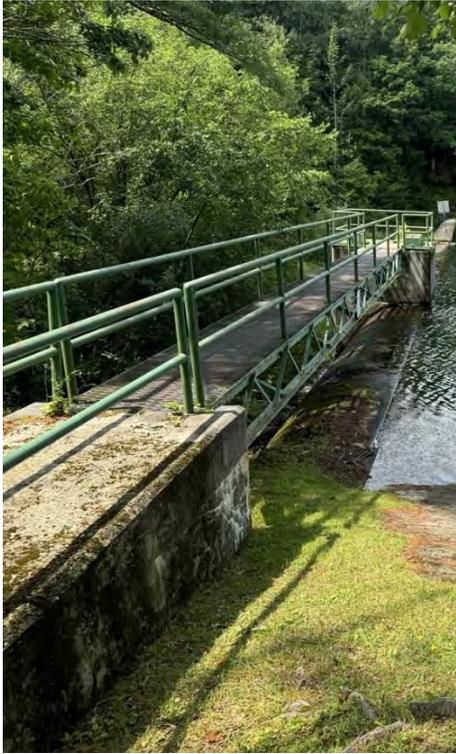
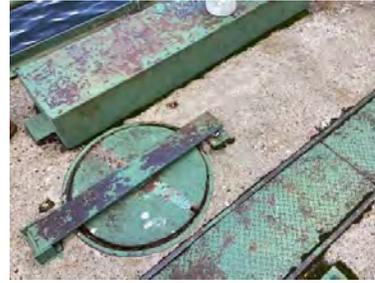
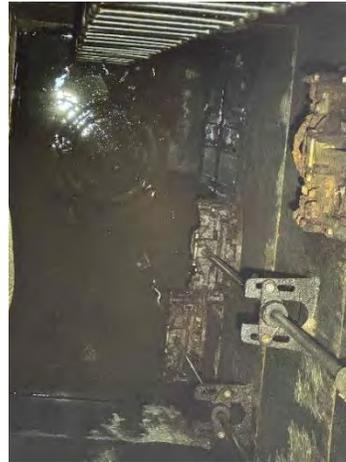
**Gate Chamber (Low-Level Outlet) Images**

Gate Chamber (Low-Level-Outlet) issues	Action
<p><b>Deteriorating protective paint coating.</b> Location: Bridge, railings, manholes/valve access points.</p>	<p><input type="checkbox"/> None  <input type="checkbox"/> Monitor  <input checked="" type="checkbox"/> Maintenance  <input type="checkbox"/> Engineer</p>
<p><b>Bulging intake screens within gate chamber.</b></p>	<p><input type="checkbox"/> None  <input checked="" type="checkbox"/> Monitor  <input checked="" type="checkbox"/> Maintenance  <input type="checkbox"/> Engineer</p>
<p><b>Standing water within gate chamber.</b></p>	<p><input type="checkbox"/> None  <input checked="" type="checkbox"/> Monitor  <input type="checkbox"/> Maintenance  <input checked="" type="checkbox"/> Engineer</p>
<p><b>Inoperable/Unknown Operability</b></p>	<p><input type="checkbox"/> None  <input type="checkbox"/> Monitor  <input checked="" type="checkbox"/> Maintenance  <input checked="" type="checkbox"/> Engineer</p>

Studies and analysis	
<i>Low-Level-Outlet &amp; Gate Chamber</i>	<ul style="list-style-type: none"> <li>Perform a confined space entry inspection of the gate chamber, evaluate the condition of the low-level-outlet and other components.</li> <li>Perform video/camera inspection of pipes.</li> <li>Identify repair, replacement, or decommissioning alternatives to restore functionality or reduce potential risks as required.</li> </ul>
<i>Emergency Action Planning</i>	<ul style="list-style-type: none"> <li>Utilize the results of the GZA 2023 dam failure analysis to update the emergency action plan (EAP), consider using DSP EAP template.</li> </ul>
<i>Operation and maintenance</i>	<ul style="list-style-type: none"> <li>Develop an Operations and Maintenance Manual for the dam (including gates) and provide a copy to the Dam Safety Program for record keeping purposes.</li> </ul>
