Potential Failure Mode Analysis and Risk Assessment Report

INDIAN BROOK RESERVOIR DAM NATDAM NO. VT000055

Re: Potential Failure Modes Analysis and Risk Assessment Report
Indian Brook Reservoir Dam – VT000055

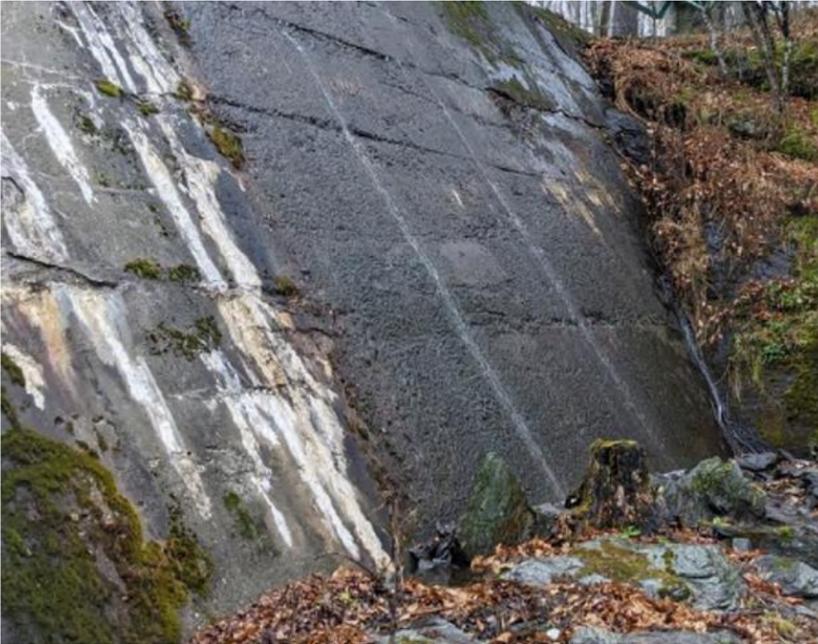
<p>Downstream face of the Principal Spillway at the rock contact (GZA, 2022)</p>

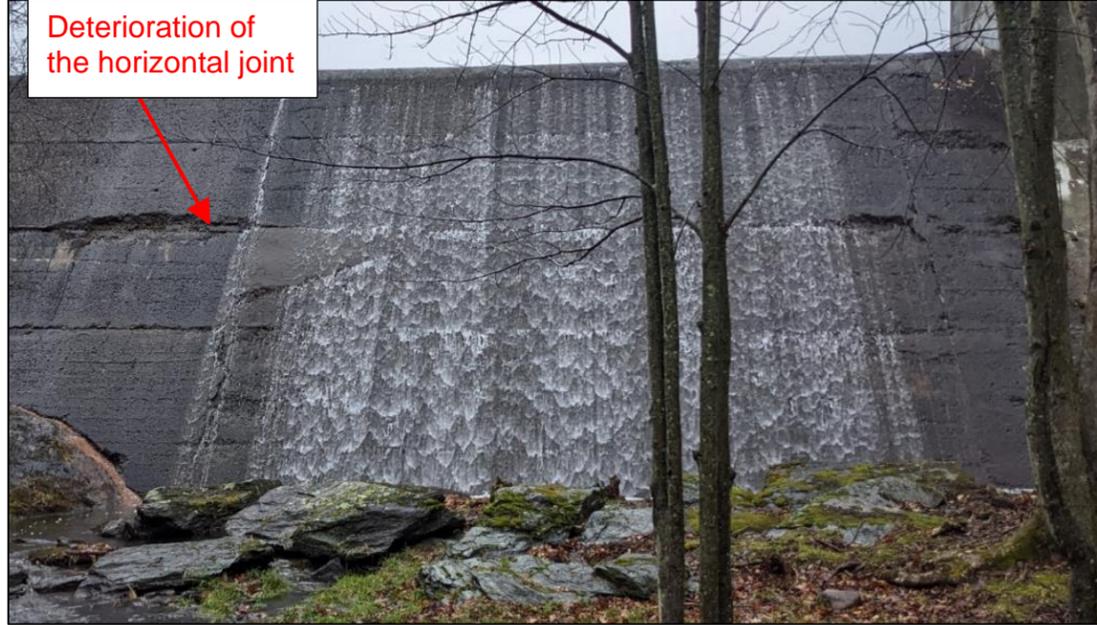
<p>Deterioration of the horizontal joint</p>	
Continuation/Progression:	<ul style="list-style-type: none"> Under the theorized loading conditions [See Note 1 under Justification]. The force acting on the structure in a downstream direction exceeds the concrete-foundation interface strength. 				
Intervention:	<ul style="list-style-type: none"> Intervention is not successful. 				
Failure:	<ul style="list-style-type: none"> A section of the spillway slides downstream. A gap is formed in the dam. An uncontrolled release of the reservoir occurs.

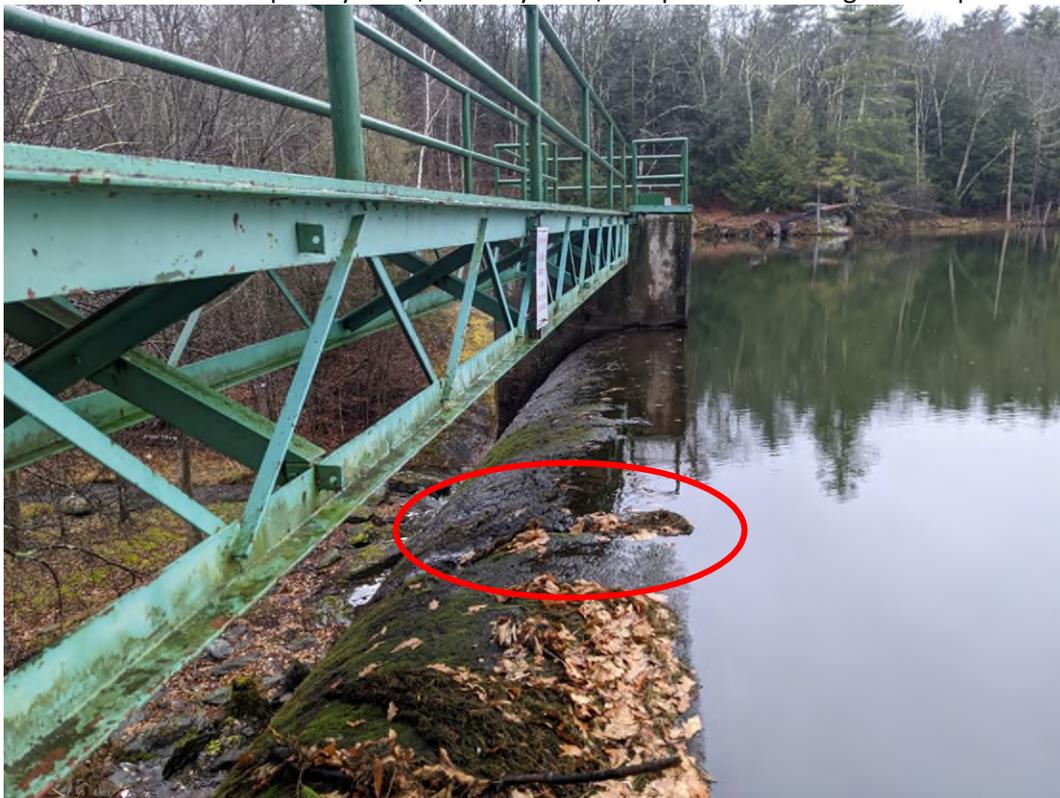
Photo 4: Close up view of the spillway crest from the top of the dam. Note the leaf litter and concrete deterioration of the spillway crest (red circle).

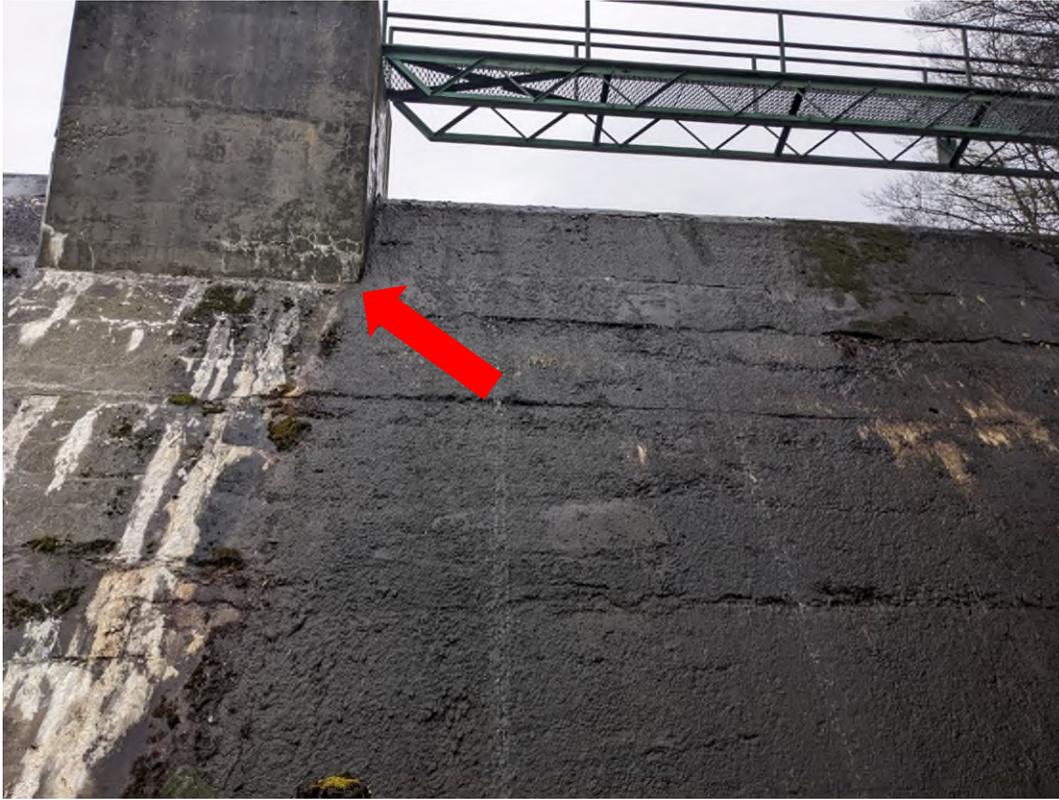
Photo 5: Minor missing grout of the construction joint of the gate chamber structure and downstream principal spillway face.

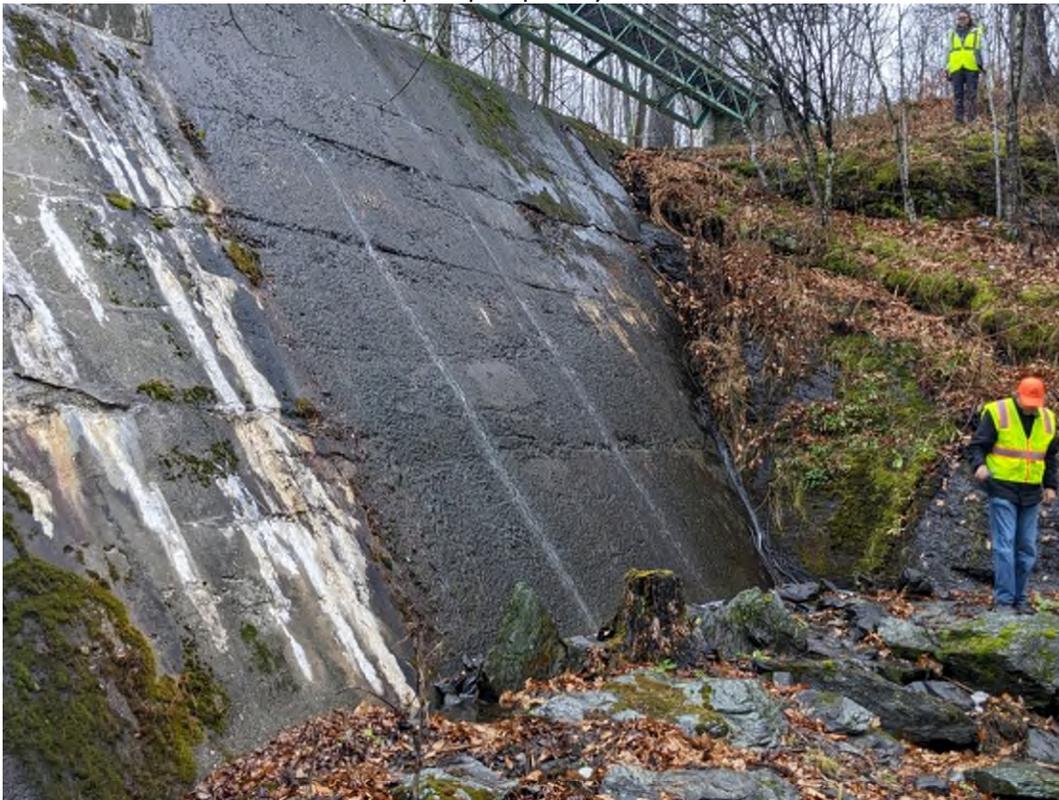
Photo 6: Note the spalling at the construction joints and efflorescence of the spillway face.

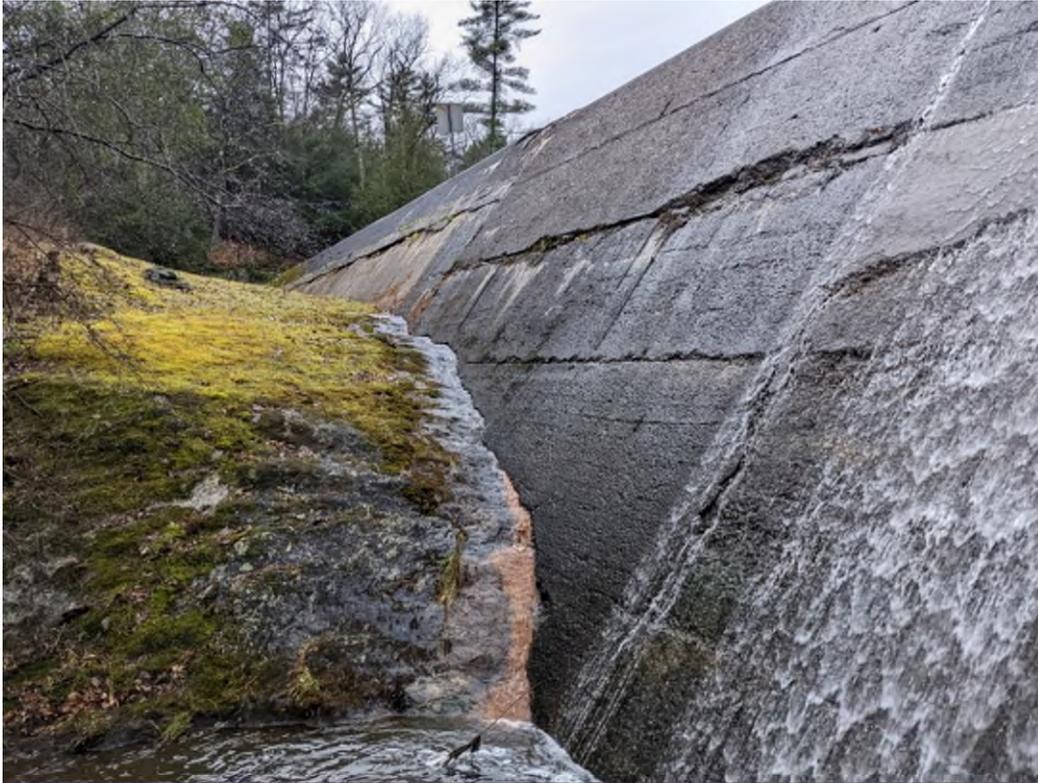
Photo 7: Principal spillway downstream, where toe bedrock elevation rises from the tailrace (foreground). Note the spalling present at the lift joints and toe with iron staining and seeping at toe.

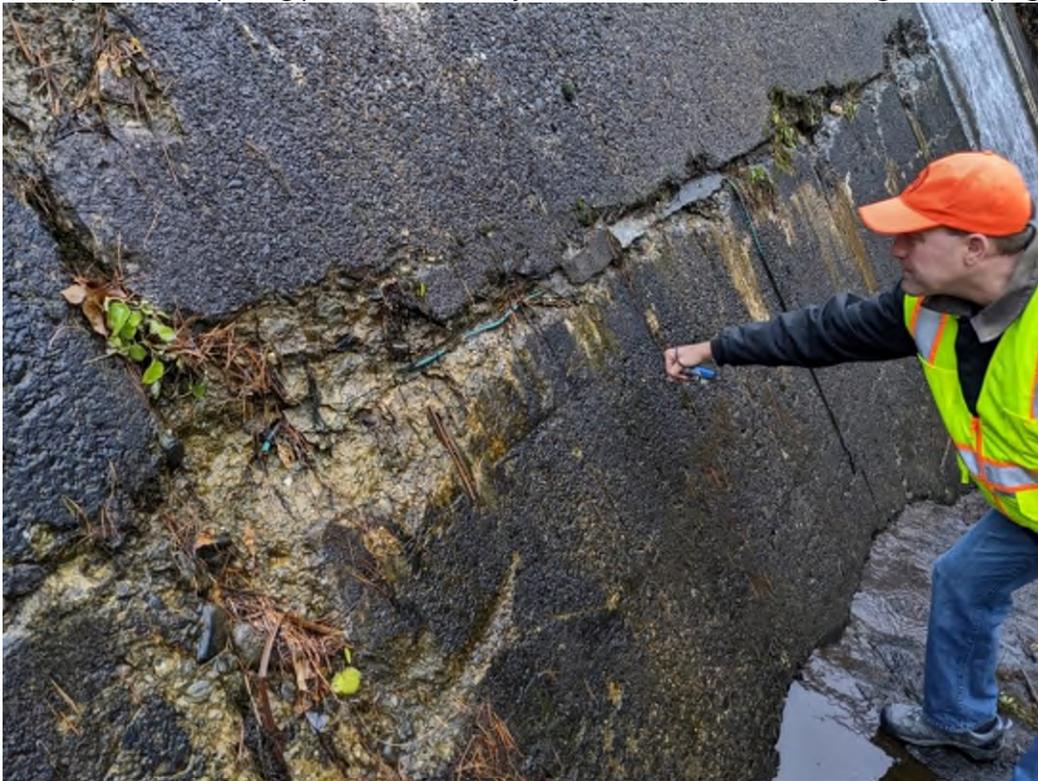
Photo 8: Prominent deterioration and joint face spalling at horizontal construction joint of the principal spillway face. Note vegetation growth in construction joint.

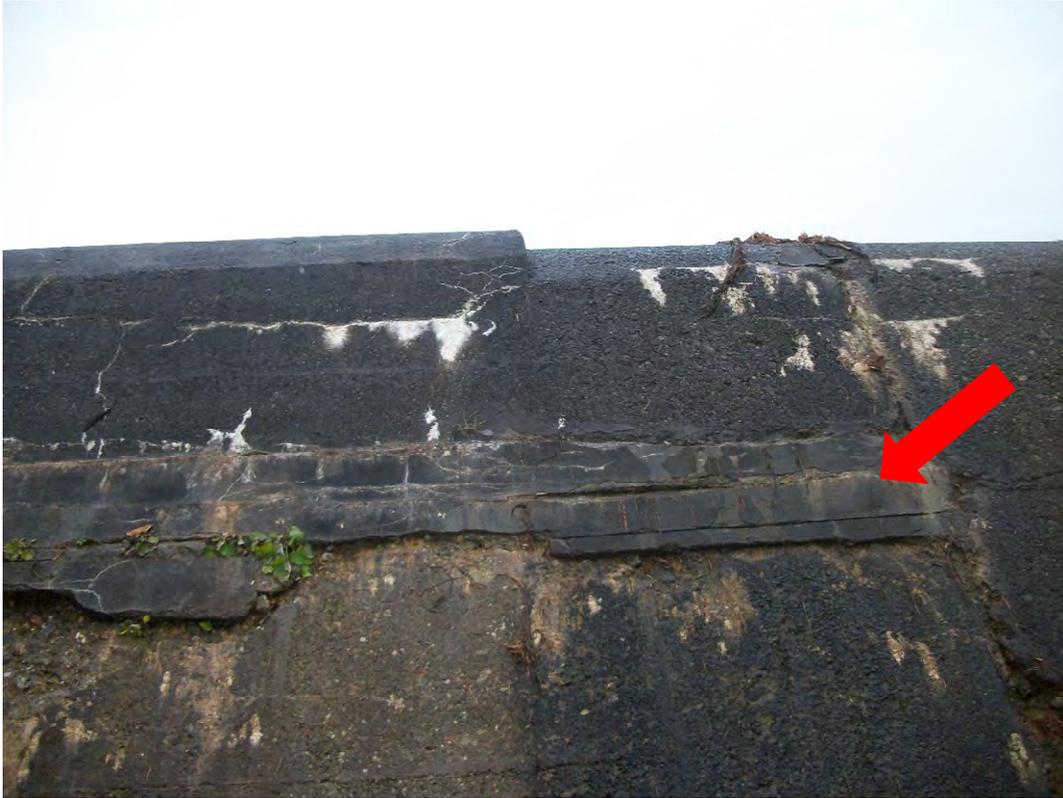
Photo 9: Close-up view of the downstream face where the dam transitions from the principal (left) to the auxiliary (right) spillway. Horizontal patchwork from 2003 concrete joint repairs (red arrow).

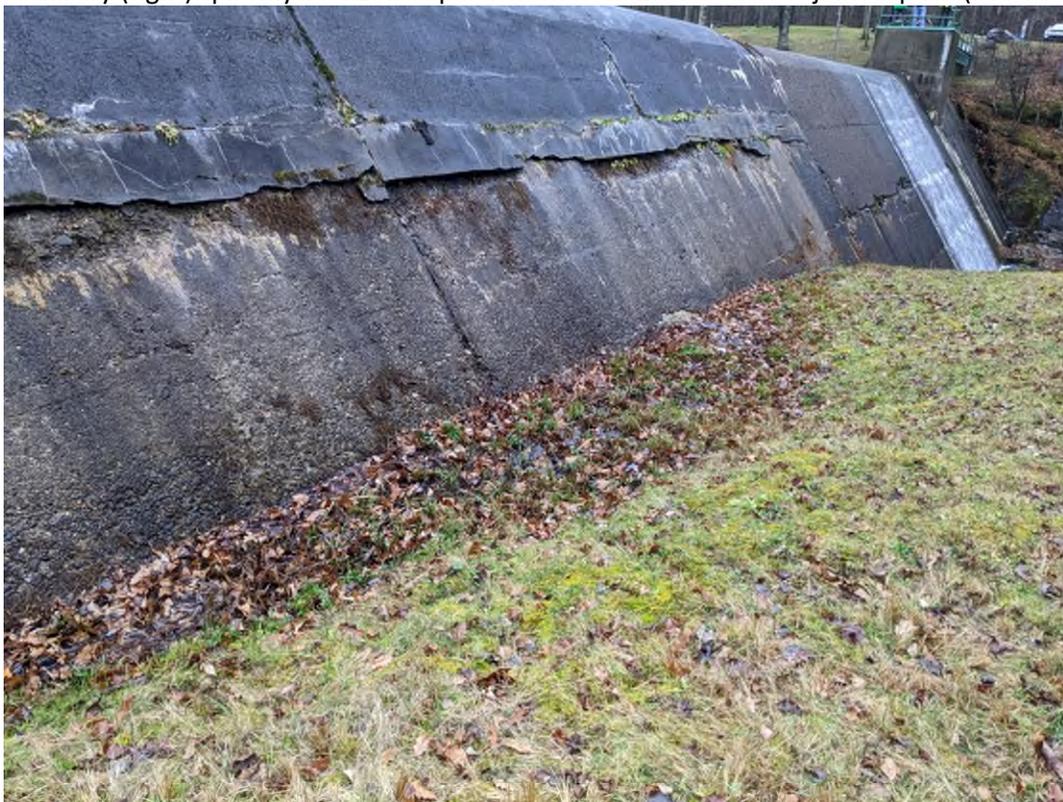
Photo 10: Auxiliary spillway downstream face with horizontal cracking.

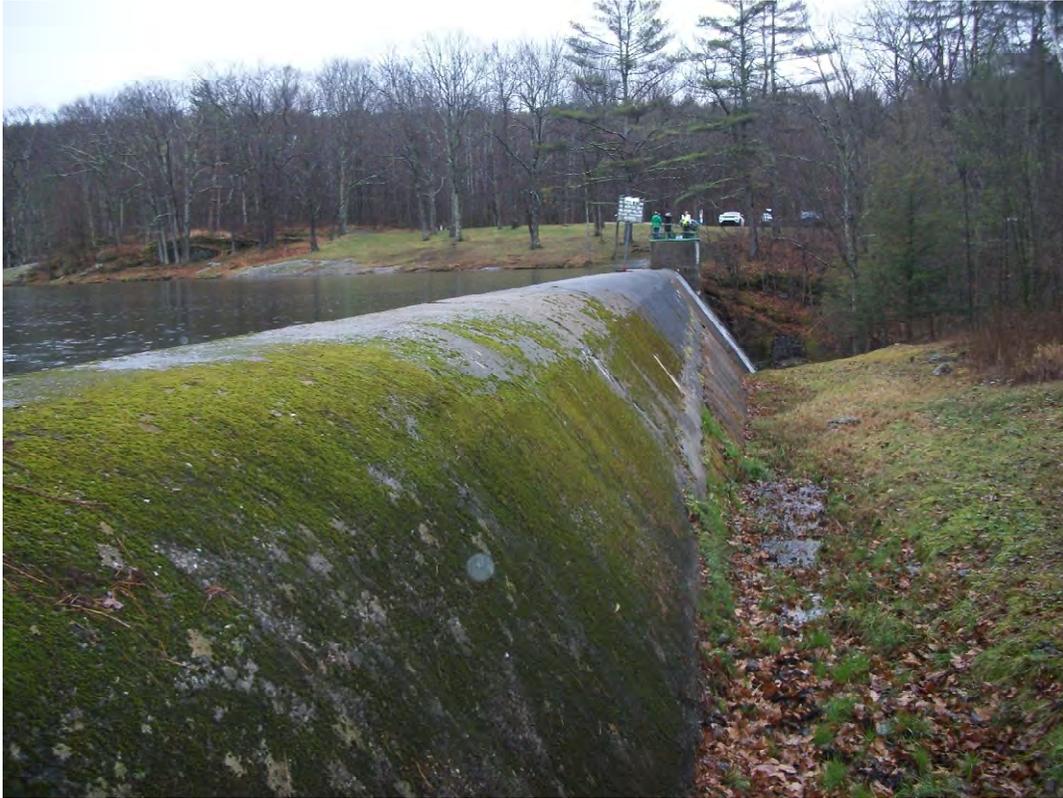
Photo 11: Moss/vegetation growth along the crest and downstream face of the auxiliary spillway. Note the seepage at the toe.

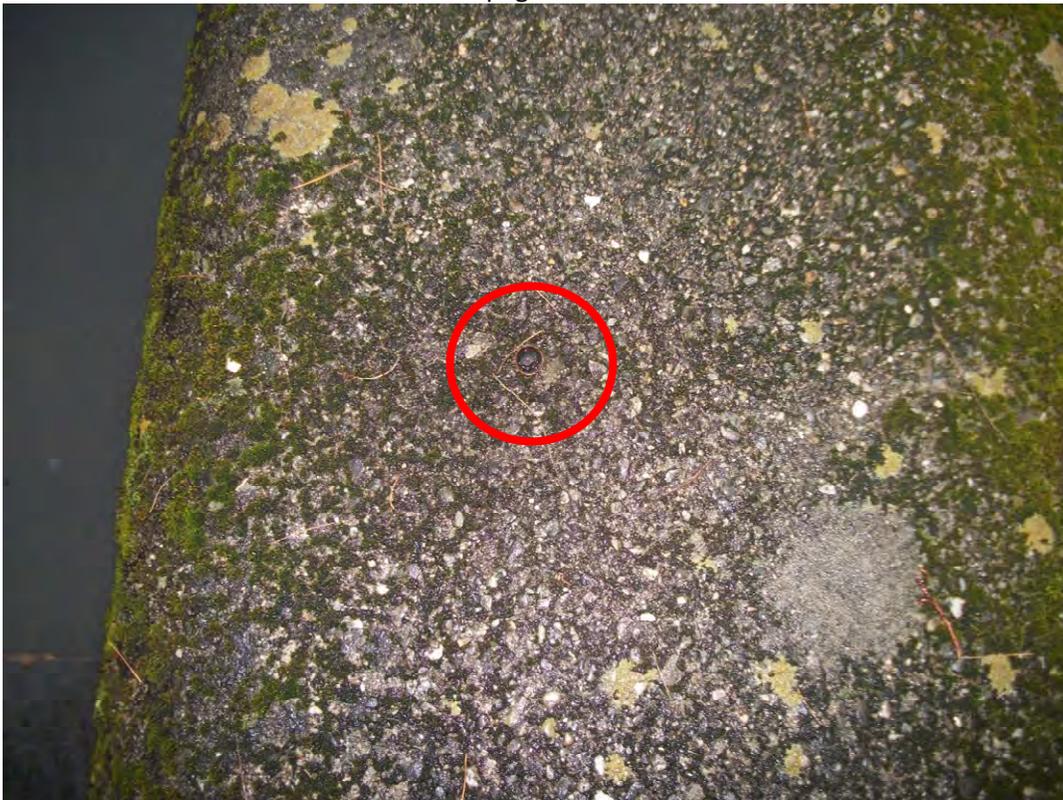
Photo 12: View of the auxiliary spillway crest with exposed rebar.

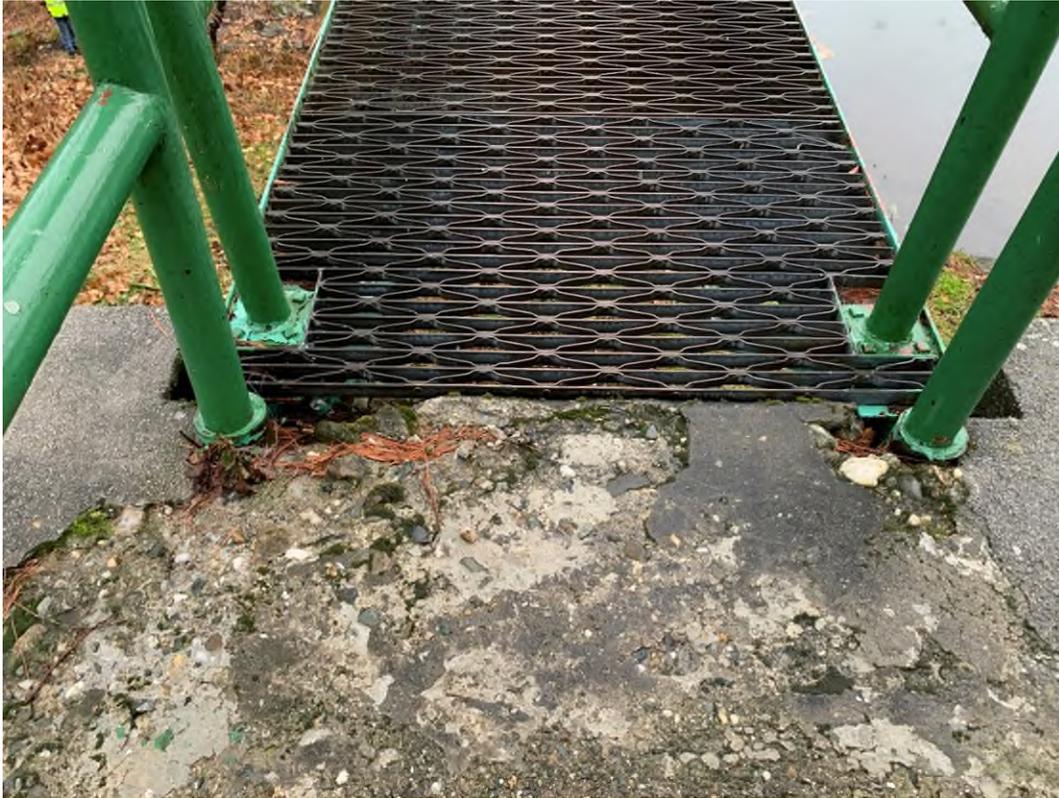
Photo 17: Spalling of concrete at the entrance of the pedestrian bridge.

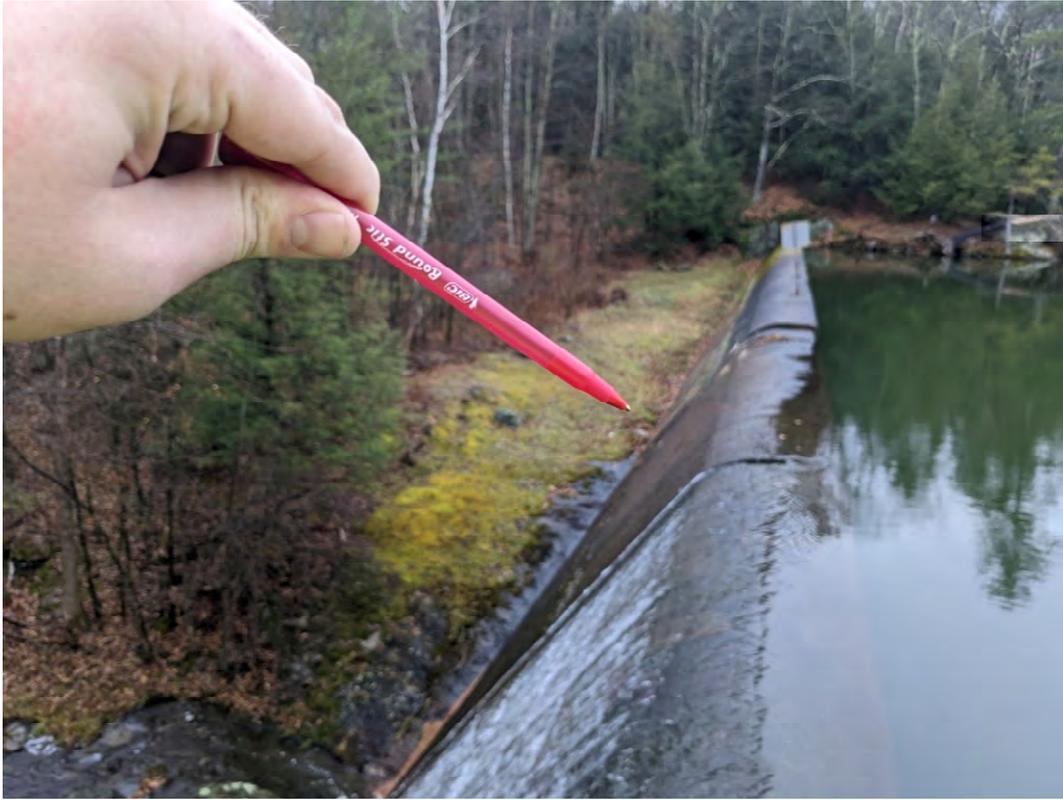
Photo 21: Approximate location of flowing water at toe of auxiliary spillway.
