Potential Failure Mode Analysis and Risk Assessment Report

INDIAN BROOK RESERVOIR DAM NATDAM NO. VT000055

Re: Potential Failure Modes Analysis and Risk Assessment Report
Indian Brook Reservoir Dam – VT000055

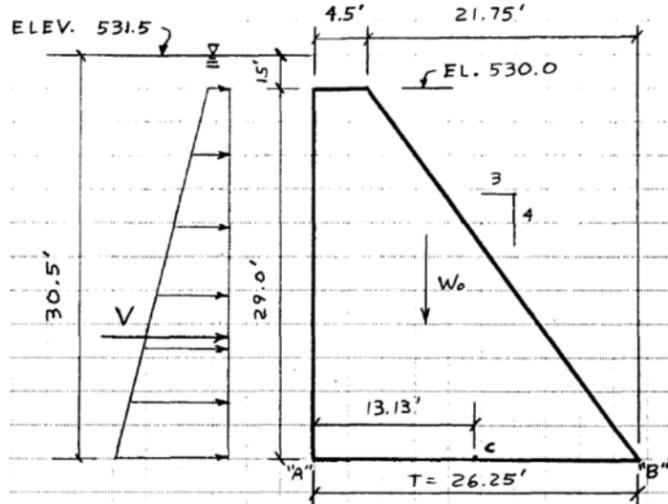
<p>Free body diagram, overtopping (1988 G & Underwood Engineering Report)</p>

Background Information			
Additional Supporting Information	<ul style="list-style-type: none"> Stability evaluations performed by GZA, 2023. 1980 USACE Phase I Inspection Report. 	Performance Monitoring Information	n/a
Evaluation Factors			
Step/Node	Adverse (More Likely)	Favorable (Less Likely)	Surveillance & Monitoring Provisions
Flaw/Initiation	<ul style="list-style-type: none"> Ice thickness at the dam can reach 12 inches, which is a typical assumed thickness in the absence of site-specific data. 	<ul style="list-style-type: none"> Ice melt is reported to typically be slow / gradual during the spring, with no large ice flows typically identified at the dam. 	<ul style="list-style-type: none"> n/a
Continuation/Progression	<ul style="list-style-type: none"> Preliminary sliding stability factors of safety for normal, flood and normal plus ice loading conditions are less than the USACE-recommended minimum values. Vertical upstream face of spillway allows full ice load to be transmitted to structure. Lack of construction information, including unknown reinforcing across lift joints, unknown monolith to monolith reinforcing, and unknown foundation treatment. Concrete deterioration noted at the vertical joints between monoliths and at horizontal construction joints; 2003 repairs failing/failed in some places. Depth of sedimentation upstream of dam is unknown, although sedimentation has been reported to not be a concern at the site. 	<ul style="list-style-type: none"> Preliminary sliding stability factors of safety exceed 1.0 for normal, flood and normal plus ice loading conditions. No known construction problems or conditions are known to have been encountered according (per USACE Phase I report). A post-earthquake inspection (October 17, 2012) was conducted with no visible/noticeable changes. Section is founded on bedrock, with sound rock exposed along the toe. Toe is free of debris, sediment, soils and vegetation, allowing for inspection to observe for signs of sliding or undermining erosion. No visible misalignment at construction joints (vertical and horizontal). 	<ul style="list-style-type: none"> Visual inspections conducted every year by VTDSP. Formal visual inspection by Owner in conjunction with VTDSP inspection, and inspection following a significant event (earthquake, microburst). Last underwater upstream inspection circa 2011.

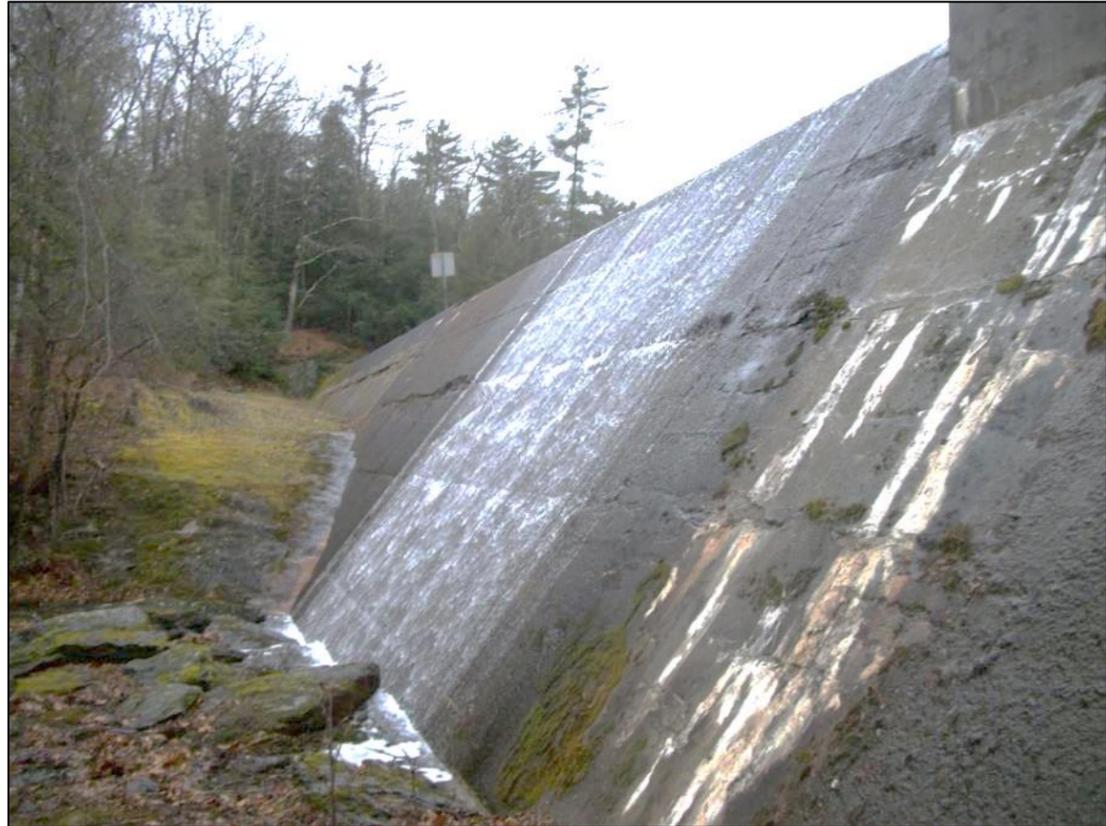
IBR-SPL-03-F-CRE EROSION/SCOUR OF THE DOWNSTREAM TOE OF THE PRINCIPAL SPILLWAY

PFM Information																																			
Structure	Principal Spillway	PFM Failure Type	Erosion/Scour	PFM Source	New																														
Loading Condition	Flood	Location(s)	Toe of the Principal Spillway	PFM Source Date	6/12/2023																														
PFM Description																																			
Flaw:	<ul style="list-style-type: none"> Overtopping of the principal spillway erodes the downstream toe of the Principal Spillway, destabilizing the structure. 		PFM Sketch(es)

Continuation/Progression:	<ul style="list-style-type: none"> There is a storm event up to and including the PMF (532.5 ft, NGVD29). As flow continues over the spillway (crest 530 ft), the downstream channel begins to scour and erode. The erosion progresses during subsequent floods until it reaches a critical distance beneath the spillway. 																																		
Intervention:	<ul style="list-style-type: none"> The erosion goes unnoticed. 																																		
Failure:	<ul style="list-style-type: none"> A section of the dam slides downstream. A gap is formed in the dam. An uncontrolled release of the reservoir occurs. 																																		
PFM Disposition	<input type="checkbox"/> Ruled Out <input type="checkbox"/> Clearly Negligible <input type="checkbox"/> Asset Management <input type="checkbox"/> Insufficient Info <input type="checkbox"/> Financial/Damage State <input checked="" type="checkbox"/> Credible <input type="checkbox"/> Urgent																																		
Classification Justification	<p>This potential failure mode is considered credible, for many of the similar reasons as IBR-SPL-01-IE.</p> <p>The results of GZA's 2023 stability study are provided below:</p>

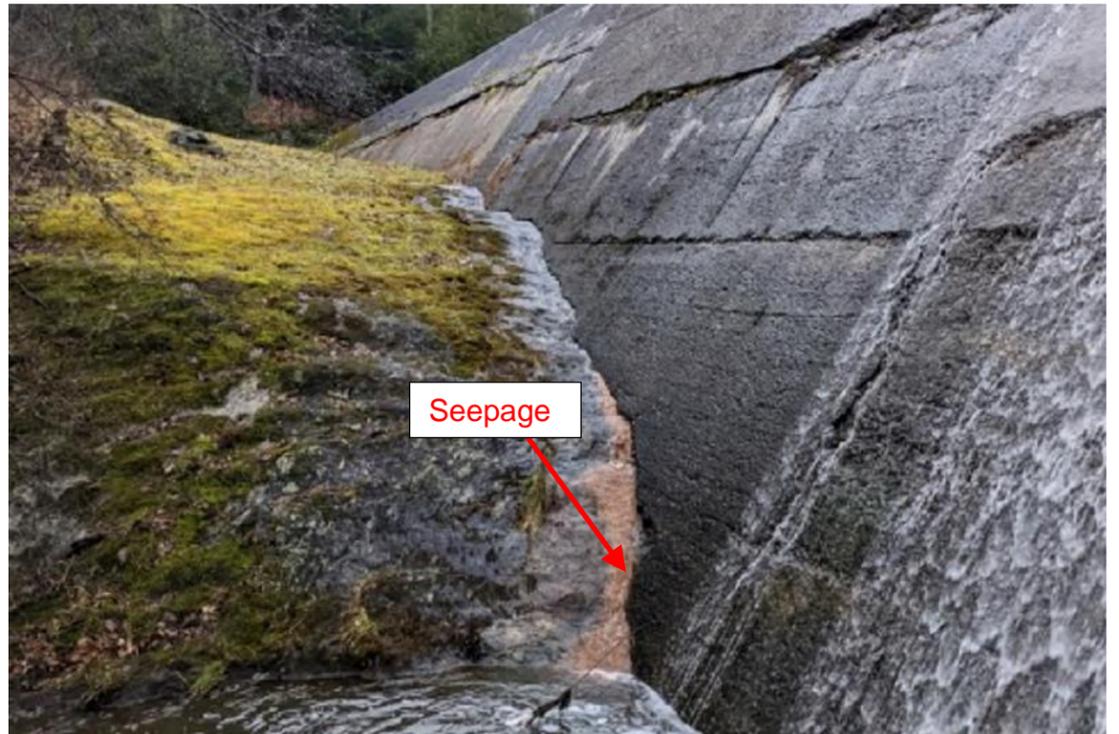
IBR-SPL-04-N-CRE DETERIORATION OF THE FOUNDATION OF THE PRINCIPAL SPILLWAY

PFM Information																																				
Structure	Principal Spillway	PFM Failure Type	Erosion/Scour	PFM Source	New																															
Loading Condition	Normal	Location(s)	Principal Spillway	PFM Source Date	6/12/2023																															
PFM Description																																				
Flaw:	<ul style="list-style-type: none"> Construction defect exists at the contact with the foundation, due to inadequate foundation preparation. Defect allows preferential seepage along the contact, increasing the destabilizing uplift pressures. 		PFM Sketch(es)

Continuation/Progression:	<ul style="list-style-type: none"> The reservoir is at normal reservoir pool. A preferential seepage path exists through a zone of inadequate foundation preparation (such as soil-infilled rock seam) which originates below the Auxiliary Spillway and daylighted downstream of the embankment. Continued seepage along the path causes the joint to open, increasing uplift pressure on the dam. The force acting on the structure in a downstream direction exceeds the concrete-foundation interface strength. 																																			
Intervention:	<ul style="list-style-type: none"> Increasing seepage volume goes unnoticed. 																																			
Failure:	<ul style="list-style-type: none"> A section of the dam slides downstream. A gap is formed in the dam. An uncontrolled release of the reservoir occurs. 																																			
PFM Disposition	<input type="checkbox"/> Ruled Out <input type="checkbox"/> Clearly Negligible <input type="checkbox"/> Asset Management <input type="checkbox"/> Insufficient Info <input type="checkbox"/> Financial/Damage State <input checked="" type="checkbox"/> Credible <input type="checkbox"/> Urgent																																			
Classification Justification	<p>This potential failure mode is considered credible. It is similar to IBR-SPL-03-F; however this PFM relates to a foundation defect under the dam, which, over time, allows for uplift pressures to increase and destabilize the dam.</p> <p>GZA performed a stability evaluation for the deepest section of the Principal Spillway, with assumed parameters (40 degree friction angle, 0 psi cohesion) for the concrete-foundation interface, following the USACE guidelines for gravity dams. The results of the stability study are provided to the right.</p> <p>The evaluation suggests that the spillway is stable (sliding factor of safety > 1.0) under normal, flood (PMF) and normal plus ice loading conditions. However, the calculated factors of safety are lower than the USACE-recommended minimum values for all cases except the PMF, unless a nominal (less than 10 psi) cohesion is assumed to exist at the interface.</p> <p>As such, increasing uplift pressures in excess of the traditionally assumed straight line profile from headwater to tailwater may have a detrimental effect on the stability of the section.</p>

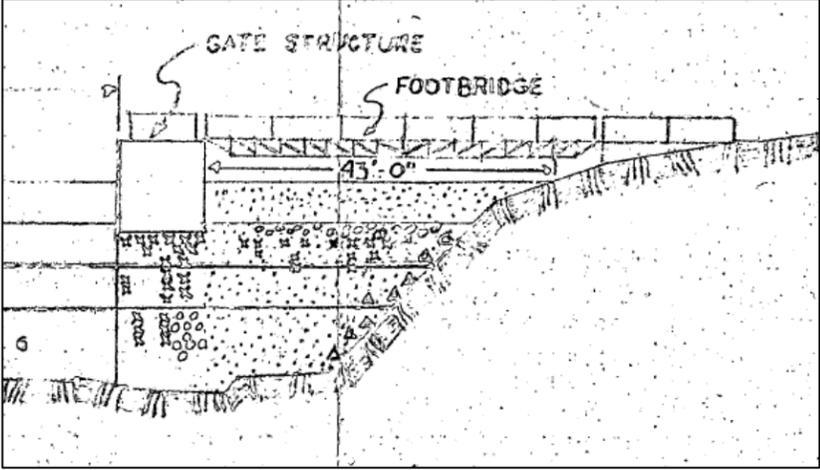
PFM Information																																		
Structure	Intake	PFM Failure Type	Stability	PFM Source	New																													
Loading Condition	Ice, Earthquake	Location(s)	Intake	PFM Source Date	6/12/2023																													
PFM Description																																		
Flaw:	<ul style="list-style-type: none"> Insufficient cross section (geometry and mass distribution) at the Intake causes hydrostatic destabilizing loads to overcome the resisting loads, causing the Principal Spillway to slide downstream. 			PFM Sketch(es)

<p>Elevation view, looking upstream (1980 USACE)</p>

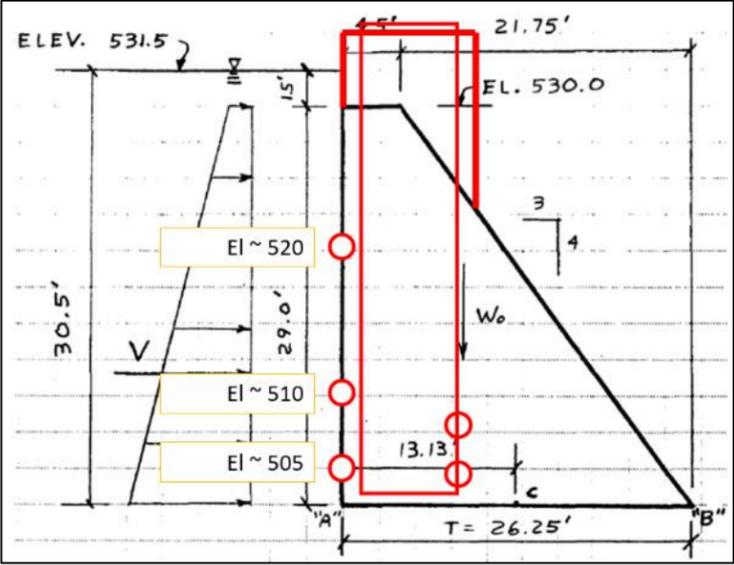
<p>Cross section, 1988 G & Underwood Engineering Report with annotations by GZA to depict Intake (three inlets, chamber and two outlets)</p>																													
Continuation/Progression:	<ul style="list-style-type: none"> Under the theorized loading conditions [See Note 1 under Justification]. The force acting on the structure in a downstream direction exceeds the concrete-foundation interface strength. 																																	
Intervention:	<ul style="list-style-type: none"> Intervention is not successful. 																																	
Failure:	<ul style="list-style-type: none"> A section of the spillway slides downstream. A gap is formed in the dam. An uncontrolled release of the reservoir occurs. 																																	
PFM Disposition	<input type="checkbox"/> Ruled Out <input type="checkbox"/> Clearly Negligible <input type="checkbox"/> Asset Management <input type="checkbox"/> Insufficient Info <input type="checkbox"/> Financial/Damage State <input checked="" type="checkbox"/> Credible <input type="checkbox"/> Urgent																																	
Classification Justification	<p>This potential failure mode is considered credible. The Intake section is integral with the Principal Spillway; as shown in the top figure to the right, the Intake is just to the left of a vertical construction joint. Specific construction records are not available; however it is expected that the vault chamber that forms the intake was formed during the placement of the Principal Spillway.</p> <p>Stability for the Intake structure itself has not been performed. Refer to IBR-SPL-01-IE for a summary of stability evaluations performed for the Principal Spillway, and a discussion establishing Ice and Earthquake as the controlling loading conditions. A cross section through the Intake (lower figure to the right) will have less mass than the general Principal Spillway (due to the open valve chamber, when the water level is near to the bottom of the chamber). The results of the stability study for the Principal Spillway are provided below:</p>

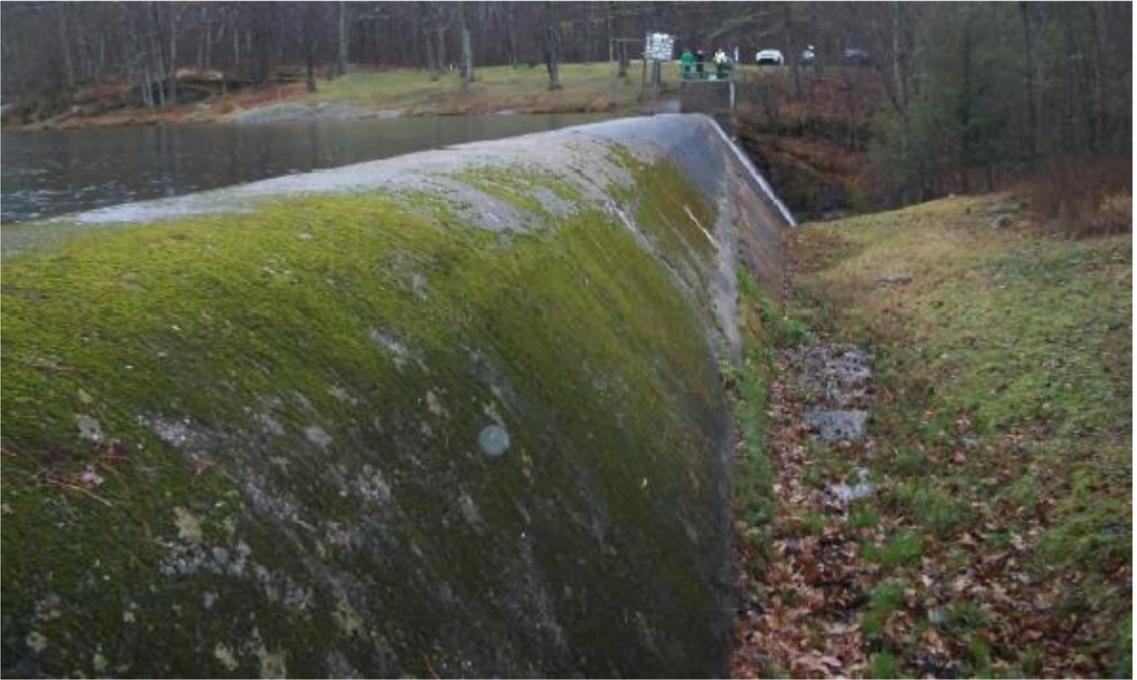
IBR-AUX-01-I-CRE SLIDING/OVERTURNING OF THE AUXILIARY SPILLWAY ALONG THE FOUNDATION

PFM Information																																				
Structure	Auxiliary Spillway	PFM Failure Type	Stability	PFM Source	New																															
Loading Condition	Ice	Location(s)	Auxiliary Spillway	PFM Source Date	6/12/2023																															
PFM Description																																				
Flaw:	<ul style="list-style-type: none"> Insufficient cross section (geometry and mass distribution) at the Auxiliary Spillway causes hydrostatic destabilizing loads to overcome the resisting loads, causing the Auxiliary Spillway to slide downstream. 		PFM Sketch(es)

Continuation/Progression:	<ul style="list-style-type: none"> The reservoir is at normal pool (to the top of the Principal Spillway), with 12 inches of ice depth in front of the dam. [See Note 1 under Justification]. The force acting on the structure in a downstream direction exceeds the concrete-foundation interface strength. 																																			
Intervention:	<ul style="list-style-type: none"> Intervention is not successful. 																																			
Failure:	<ul style="list-style-type: none"> A section of the spillway slides downstream. A gap is formed in the dam. An uncontrolled release of the reservoir occurs. 																																			
PFM Disposition	<input type="checkbox"/> Ruled Out <input type="checkbox"/> Clearly Negligible <input type="checkbox"/> Asset Management <input type="checkbox"/> Insufficient Info <input type="checkbox"/> Financial/Damage State <input checked="" type="checkbox"/> Credible <input type="checkbox"/> Urgent																																			
Classification Justification	<p>This potential failure mode is considered credible.</p> <p>Note 1. GZA performed a stability evaluation for the Auxiliary Spillway, with assumed parameters (40 degree friction angle, 0 psi cohesion) for the concrete-foundation interface, following the USACE guidelines for gravity dams. The results of the stability study are provided to the right.</p> <p>The evaluation suggests that the spillway is stable (sliding FS > 1.0) under normal, flood (PMF), and normal plus ice loading conditions. The calculated factors of safety are lower than the USACE-recommended minimum values for all cases except the PMF, unless a nominal (less than 5 psi) cohesion is assumed to exist at the interface. The normal plus ice loading (5,000 lb ice load applied 0.5 feet below the spillway crest) condition had the lowest calculated factor of safety of the static loading conditions. As such, this PFM is tailored toward the ice loading condition.</p> <p>The GZA stability evaluation also suggests that the Auxiliary Spillway is stable (factor of safety of 1.0) during the 2,475 year seismic event (2% in 50 year event), when analyzed via pseudodynamic methods. This type of analysis is considered a preliminary estimate, with more refined dynamic modeling typically performed.</p>		<p><i>Downstream face of the Auxiliary Spillway at the rock contact (GZA, 2022)</i></p>

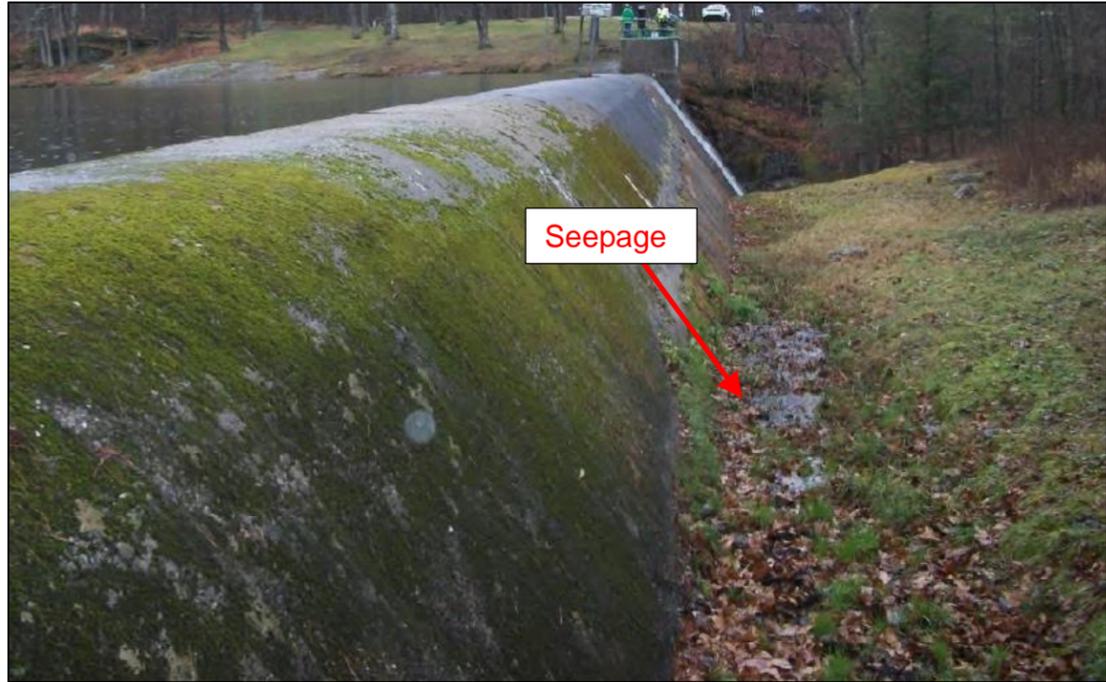
IBR-AUX-04-N-CRE DETERIORATION OF THE FOUNDATION OF THE AUXILIARY SPILLWAY

PFM Information																																			
Structure	Auxiliary Spillway	PFM Failure Type	Erosion/Scour	PFM Source	New																														
Loading Condition	Normal	Location(s)	Auxiliary Spillway	PFM Source Date	6/12/2023																														
PFM Description																																			
Flaw:	<ul style="list-style-type: none"> Construction defect exists at the contact with the foundation, due to inadequate foundation preparation. Defect allows preferential seepage along the contact, increasing the destabilizing uplift pressures. 		PFM Sketch(es)

Continuation/Progression:	<ul style="list-style-type: none"> The reservoir is at normal reservoir pool. A preferential seepage path exists through a zone of inadequate foundation preparation (such as soil-infilled rock seam) which originates below the Auxiliary Spillway and daylights downstream of the embankment. Continued seepage along the path causes the joint to open, increasing uplift pressure on the dam. The force acting on the structure in a downstream direction exceeds the concrete-foundation interface strength. 																																		
Intervention:	<ul style="list-style-type: none"> Increasing seepage volume goes unnoticed. 																																		
Failure:	<ul style="list-style-type: none"> A section of the dam slides downstream. A gap is formed in the dam. An uncontrolled release of the reservoir occurs. 																																		
PFM Disposition	<input type="checkbox"/> Ruled Out <input type="checkbox"/> Clearly Negligible <input type="checkbox"/> Asset Management <input type="checkbox"/> Insufficient Info <input type="checkbox"/> Financial/Damage State <input checked="" type="checkbox"/> Credible <input type="checkbox"/> Urgent																																		
Classification Justification	<p>This potential failure mode is considered credible. This PFM relates to a foundation defect under the dam, which, over time, allows for uplift pressures to increase and destabilize the dam.</p> <p>GZA performed a stability evaluation for the Auxiliary Spillway, with assumed parameters (40 degree friction angle, 0 psi cohesion) for the concrete-foundation interface, following the USACE guidelines for gravity dams. The results of the stability study are provided to the right:</p> <p>The evaluation suggests that the spillway is stable (sliding factor of safety > 1.0) under normal, flood (PMF), normal plus ice and earthquake loading conditions. However, the calculated factors of safety are lower than the USACE-recommended minimum values for all cases except the PMF, unless a nominal (less than 5 psi) cohesion is assumed to exist at the interface.</p> <p>As such, increasing uplift pressures in excess of the traditionally assumed straight line profile from headwater to tailwater may have a detrimental effect on the stability of the section.</p>

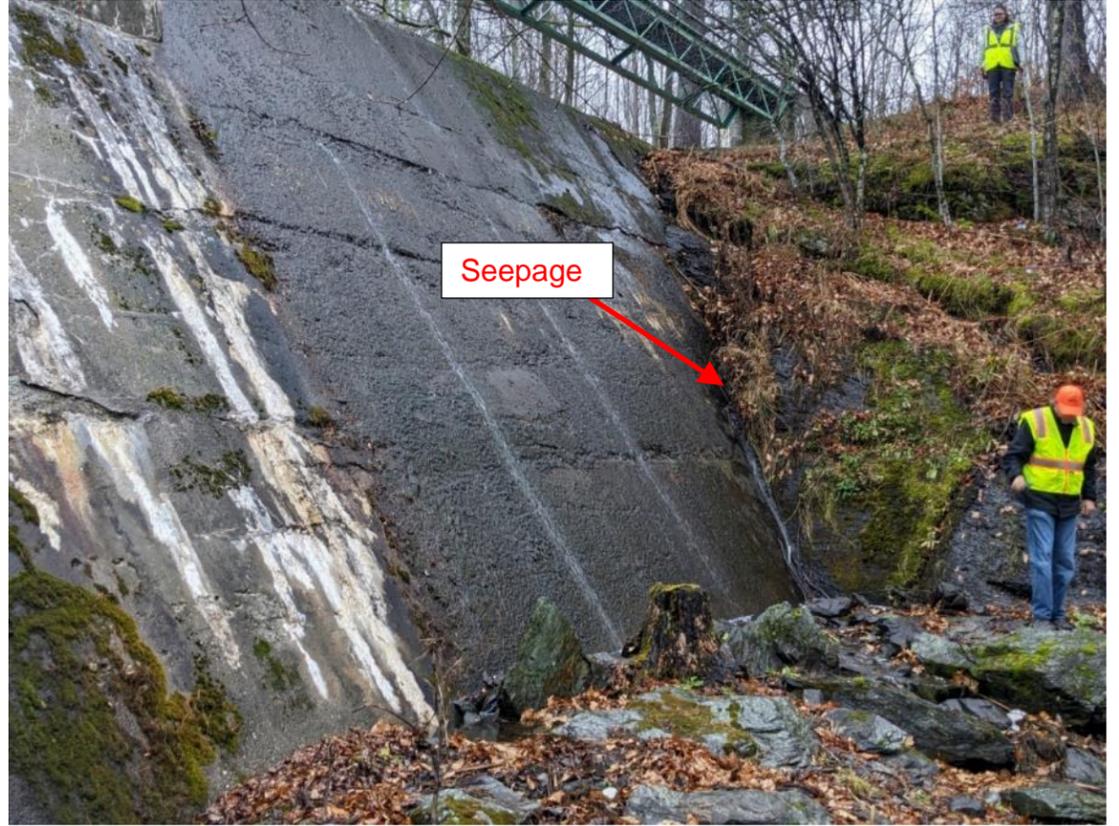
IBR-SPL-05-N-NEG SEEPAGE THROUGH THE LEFT ABUTMENT OF THE PRINCIPAL SPILLWAY

PFM Information					
Structure	Principal Spillway	PFM Failure Type	Erosion/Scour	PFM Source	New
Loading Condition	Normal	Location(s)	Principal Spillway	PFM Source Date	6/12/2023
PFM Description					
Flaw:	<ul style="list-style-type: none"> Construction defect exists at the left abutment (rock hillside) contact with the dam, due to inadequate foundation preparation. Defect allows preferential seepage along the contact, increasing the destabilizing uplift pressures. 		PFM Sketch(es)

Continuation/Progression:	<ul style="list-style-type: none"> The reservoir is at normal reservoir pool. A preferential seepage path exists through a zone of inadequate foundation preparation (such as soil-infilled rock seam) which originates in the abutment and daylighted downstream of the embankment. Continued seepage along the path causes the joint to open, increasing seepage volume through the abutment. The force acting on the structure in a downstream direction exceeds the resisting load of a rock mass along the abutment.

Intervention:	<ul style="list-style-type: none"> Increasing seepage volume goes unnoticed. 				
Failure:	<ul style="list-style-type: none"> A section of the abutment rock shifts downstream. A gap is formed bypassing the dam. An uncontrolled release of the reservoir occurs. 				
PFM Disposition	<input type="checkbox"/> Ruled Out <input checked="" type="checkbox"/> Clearly Negligible <input type="checkbox"/> Asset Management <input type="checkbox"/> Insufficient Info <input type="checkbox"/> Financial/Damage State <input type="checkbox"/> Credible <input type="checkbox"/> Urgent				
Classification Justification	<p>This potential failure mode is considered Clearly Negligible. Historically, seepage has been noted at the contact between the dam and the rock abutment. It is possible that increasing seepage flows could cause rock jointing in the abutment to open, destabilizing the abutment and causing isolated rock blocks to fail. However, there is currently no indication that the integrity of the hillside has been compromised. Additionally, concrete is by its nature generally resistant to erosion by low volume / low pressure water flow.</p>

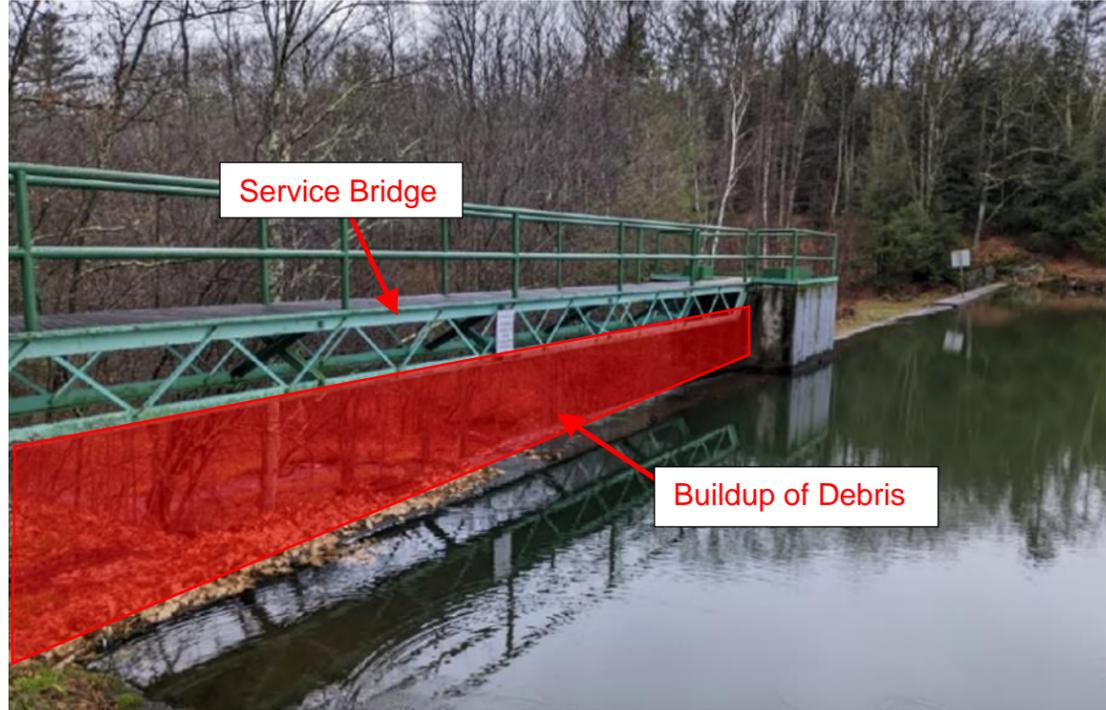
IBR-SPL-06-F-ASM DEBRIS BUILDUP AT THE SPILLWAY RAISES THE RESERVOIR

PFM Information					
Structure	Principal Spillway	PFM Failure Type	Stability	PFM Source	New
Loading Condition	Flood	Location(s)	Principal Spillway	PFM Source Date	6/12/2023
PFM Description					
Flaw:	<ul style="list-style-type: none"> A buildup of debris collects along the upstream face of the spillway, between the abutment and the intake, which hangs up on the underside of the service bridge. This throttles the discharge capacity of the spillway, causing the reservoir to rise above the PMF elevation. 		PFM Sketch(es)

Continuation/Progression:	<ul style="list-style-type: none"> There is a flood up to the PMF. A debris field (trash, trees and other river borne debris) grows and becomes lodged upstream of the spillway, impeding flow over the spillway. Due to the lost spillway capacity, the reservoir rises above the PMF elevation. The force acting on the structure in a downstream direction exceeds the concrete-foundation interface strength at the foundation.

Intervention:	<ul style="list-style-type: none"> Intervention to break up the debris field to allow it to pass over the Principal Spillway is unsuccessful. 				
Failure:	<ul style="list-style-type: none"> A section of the dam slides downstream. A gap is formed in the dam. An uncontrolled release of the reservoir occurs. 				
PFM Disposition	<input type="checkbox"/> Ruled Out <input type="checkbox"/> Clearly Negligible <input checked="" type="checkbox"/> Asset Management <input type="checkbox"/> Insufficient Info <input type="checkbox"/> Financial/Damage State <input type="checkbox"/> Credible <input type="checkbox"/> Urgent				
Classification Justification	<p>This potential failure mode is considered to have an Asset Management disposition. There may be structural damage to the Service Bridge in the event of formation of a significant debris mat (or impact from debris passing over the spillway), which would require restoration to allow safe access to the Intake.</p> <p>Per the Owner, debris buildup on the reservoir, and at the dam, is limited, with most debris washed over the spillway during overtopping events. Were a debris mat to form to the left of the intake, assisted by debris (such as trees) hung up against the underside of the service bridge, 43 feet of the spillway could be blocked, with another 195 feet (Principal and Auxiliary) available for passing flow. There is also several feet of clearance between the top of the spillway and the underside of the Service Bridge, making it less likely that debris would impinge and be hung up below the bridge.</p>		<p>Potential critical area for debris mat formation (GZA, 2022)</p>

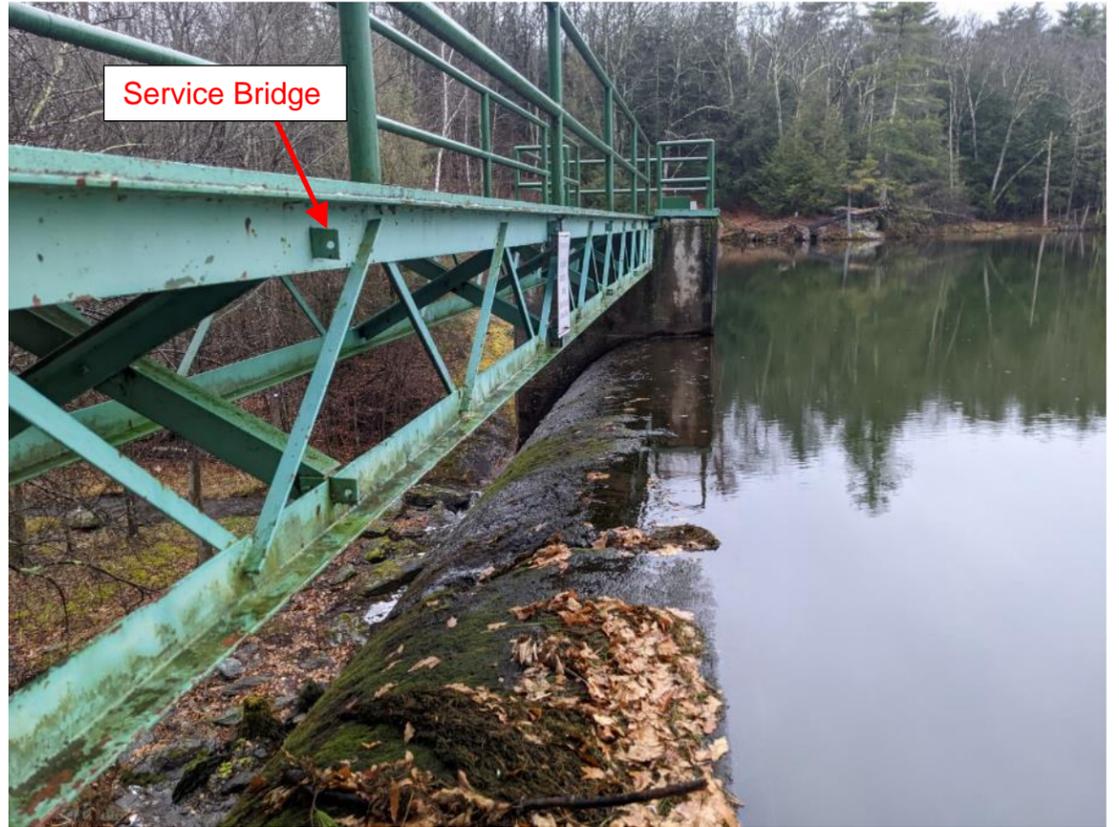
IBR-SPL-07-F-R/O STRUCTURAL FAILURE OF SERVICE BRIDGE DURING FLOOD

PFM Information					
Structure	Principal Spillway	PFM Failure Type	Stability	PFM Source	New
Loading Condition	Flood	Location(s)	Principal Spillway	PFM Source Date	6/12/2023
PFM Description					
Flaw:	<ul style="list-style-type: none"> The Service Bridge fails during a flood in such a manner that flow over the Principal Spillway is impeded. This throttles the discharge capacity of the spillway, causing the reservoir to rise above the PMF elevation. 		PFM Sketch(es)

Continuation/Progression:	<ul style="list-style-type: none"> There is a flood up to the PMF. The Service Bridge fails structurally, dropping vertical downwards and resting high on the downstream face of the Principal Spillway. Due to the lost spillway capacity, the reservoir rises above the PMF elevation. The force acting on the structure in a downstream direction exceeds the concrete-foundation interface strength at the foundation.

Intervention:	<ul style="list-style-type: none"> Intervention to dislodge the Service Bridge to allow it to fall off the face of the Spillway is unsafe to perform, or unsuccessful. 				
Failure:	<ul style="list-style-type: none"> A section of the dam slides downstream. A gap is formed in the dam. An uncontrolled release of the reservoir occurs. 				
PFM Disposition	<input checked="" type="checkbox"/> Ruled Out <input type="checkbox"/> Clearly Negligible <input type="checkbox"/> Asset Management <input type="checkbox"/> Insufficient Info <input type="checkbox"/> Financial/Damage State <input type="checkbox"/> Credible <input type="checkbox"/> Urgent				
Classification Justification	<p>This potential failure mode is considered to be Ruled Out. If the Service Bridge to fail, it would require replacement to allow safe access to the Intake.</p> <p>Based upon the inspection completed in 2022, there were no obvious signs of overstress, no signs of significant steel deterioration, no areas of concern for significant rusting, and no obvious signs of unsafe performance of the Service Bridge. As can be seen in the photograph to the right, where the Service Bridge to fail at its supports and drop vertically downwards, its center of gravity is in line with the downstream face of the Spillway; this would encourage the Service Bridge to roll down off of the face and towards the toe. The PFMA Team could not postulate a mechanism in which failure of the Service Bridge would lead to failure of the dam.</p> <p>It is noted that although access to the Intake is not required for flood operations, it is recommended that the Owner continue to maintain and repair the Service Bridge, as necessary, to maintain its continued safe performance.</p>

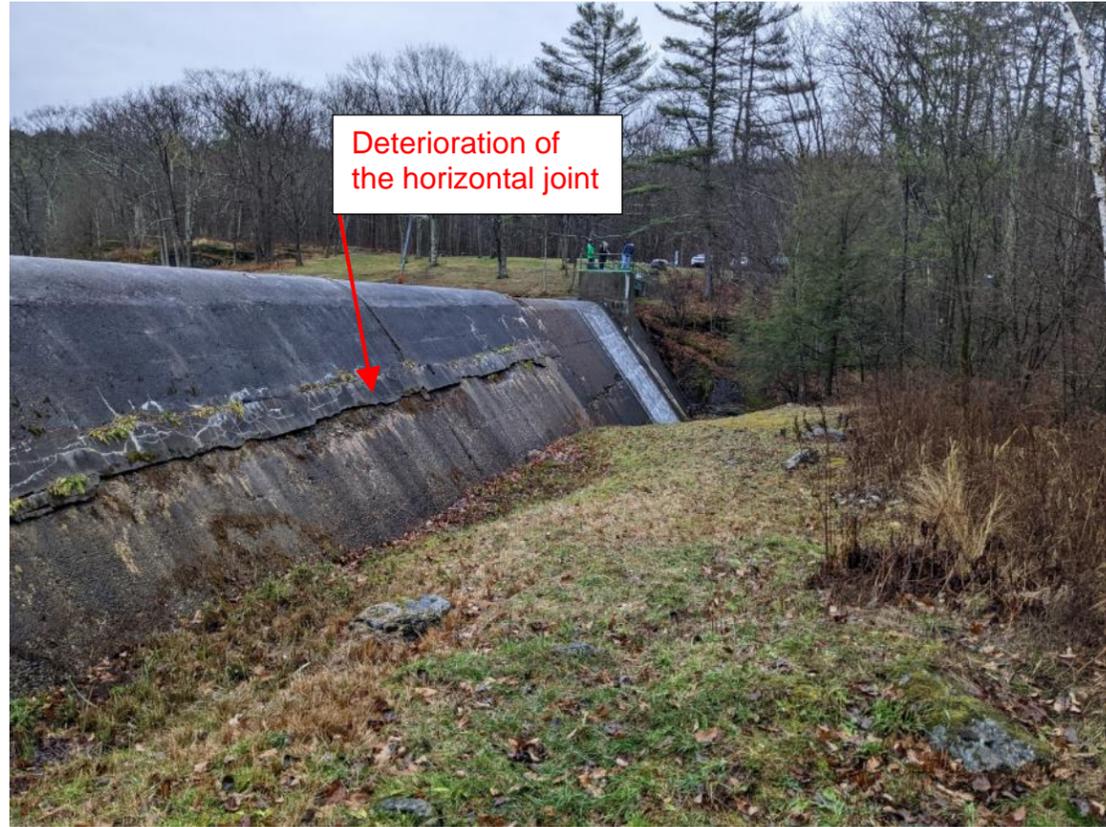
IBR-AUX-02-N-ASM SLIDING/OVERTURNING OF THE AUXILIARY SPILLWAY AT A CONSTRUCTION JOINT

PFM Information					
Structure	Auxiliary Spillway	PFM Failure Type	Stability	PFM Source	New
Loading Condition	Normal	Location(s)	Auxiliary Spillway	PFM Source Date	6/12/2023
PFM Description					
Flaw:	<ul style="list-style-type: none"> Ongoing deterioration of the concrete at the construction joint. 		PFM Sketch(es)

Continuation/Progression:	<ul style="list-style-type: none"> The reservoir is at normal pool. Additional concrete loss at horizontal construction joints due to overtopping and seasonal freeze/thaw action. Leakage begins along the joints. The leakage causes the existing spalls to widen/deepen at the joints. Increase of uplift along the construction joint. 				
Intervention:	<ul style="list-style-type: none"> Concrete deterioration is noted, but repairs are not successful. 				
Failure:	<ul style="list-style-type: none"> The force acting on the structure in a downstream direction exceeds the concrete-concrete interface strength. A section of the dam slides downstream. A gap is formed in the dam. An uncontrolled release of the reservoir to the elevation of the joint occurs.

PFM Disposition	<input type="checkbox"/> Ruled Out <input type="checkbox"/> Clearly Negligible <input checked="" type="checkbox"/> Asset Management <input type="checkbox"/> Insufficient Info <input type="checkbox"/> Financial/Damage State <input type="checkbox"/> Credible <input type="checkbox"/> Urgent				
Classification Justification	<p>This potential failure mode is considered to have an Asset Management disposition.</p> <p>The Auxiliary Spillway is a relatively short height spillway section, with a prominent horizontal construction joint located approximately 5 feet below the ogee crest. The surface of this joint has noted spalling, and was previously patched in 2003. The Auxiliary Spillway was apparently constructed with three monoliths of approximately similar lengths; were the Auxiliary Spillway to fail at the construction joint, a flow path approximately 42 feet wide by 5 feet deep could be opened. The ensuing discharge would quickly route back to the downstream river channel, and cause the reservoir to lower about 4.5 feet from the normal pool to the top of the construction joint. It is not anticipated that this limited breach would cause life loss downstream of the dam, but repairs would be required to restore the failed concrete section.</p>

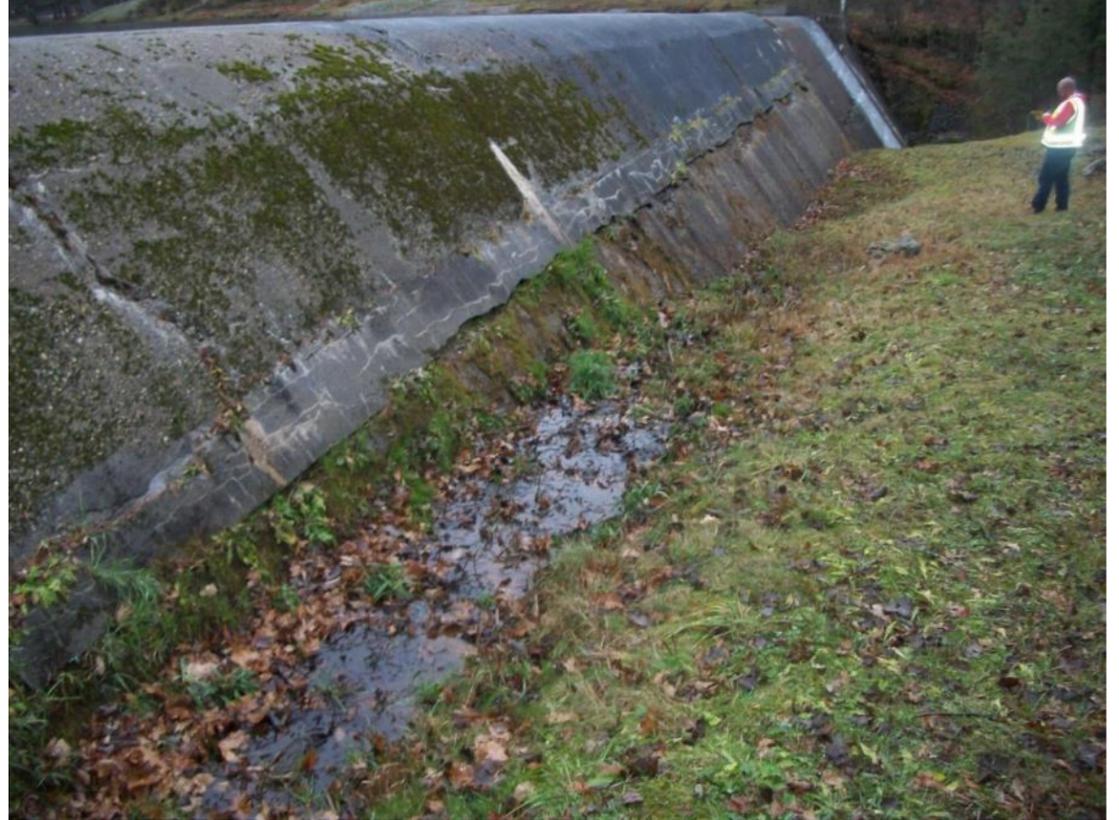
IBR-AUX-03-F-NEG EROSION/SCOUR OF THE DOWNSTREAM TOE OF THE AUXILIARY SPILLWAY

PFM Information					
Structure	Auxiliary Spillway	PFM Failure Type	Erosion/Scour	PFM Source	New
Loading Condition	Flood	Location(s)	Toe of the Auxiliary Spillway	PFM Source Date	6/12/2023
PFM Description					
Flaw:	<ul style="list-style-type: none"> Overtopping of the principal spillway erodes the downstream toe of the Auxiliary Spillway, destabilizing the structure. 		PFM Sketch(es)

Continuation/Progression:	<ul style="list-style-type: none"> There is a storm event up to and including the PMF. As flow continues over the spillway, the downstream channel begins to scour and erode. The erosion progresses during subsequent floods until it reaches a critical distance beneath the spillway. 				
Intervention:	<ul style="list-style-type: none"> The erosion goes unnoticed. 				
Failure:	<ul style="list-style-type: none"> A section of the dam slides downstream. A gap is formed in the dam. An uncontrolled release of the reservoir occurs.

PFM Disposition	<input type="checkbox"/> Ruled Out <input checked="" type="checkbox"/> Clearly Negligible <input type="checkbox"/> Asset Management <input type="checkbox"/> Insufficient Info <input type="checkbox"/> Financial/Damage State <input type="checkbox"/> Credible <input type="checkbox"/> Urgent				
Classification Justification	<p>This potential failure mode is considered Clearly Negligible. The Auxiliary Spillway is founded on bedrock, with expected shallow bedrock covered by a thin soil layer at the toe. Based up historic hydraulic evaluation, the Auxiliary Spillway is predicted to overtop by 0.1 feet during the 1.5 x 100 year event (although it is noted that the overtopping during the PMF is expected to be more significant). It is not expected that this limited overtopping jet would have sufficient impact force to cause toe erosion/scour.</p>				
Risk Assessment		Failure Likelihood & Life Safety Consequences

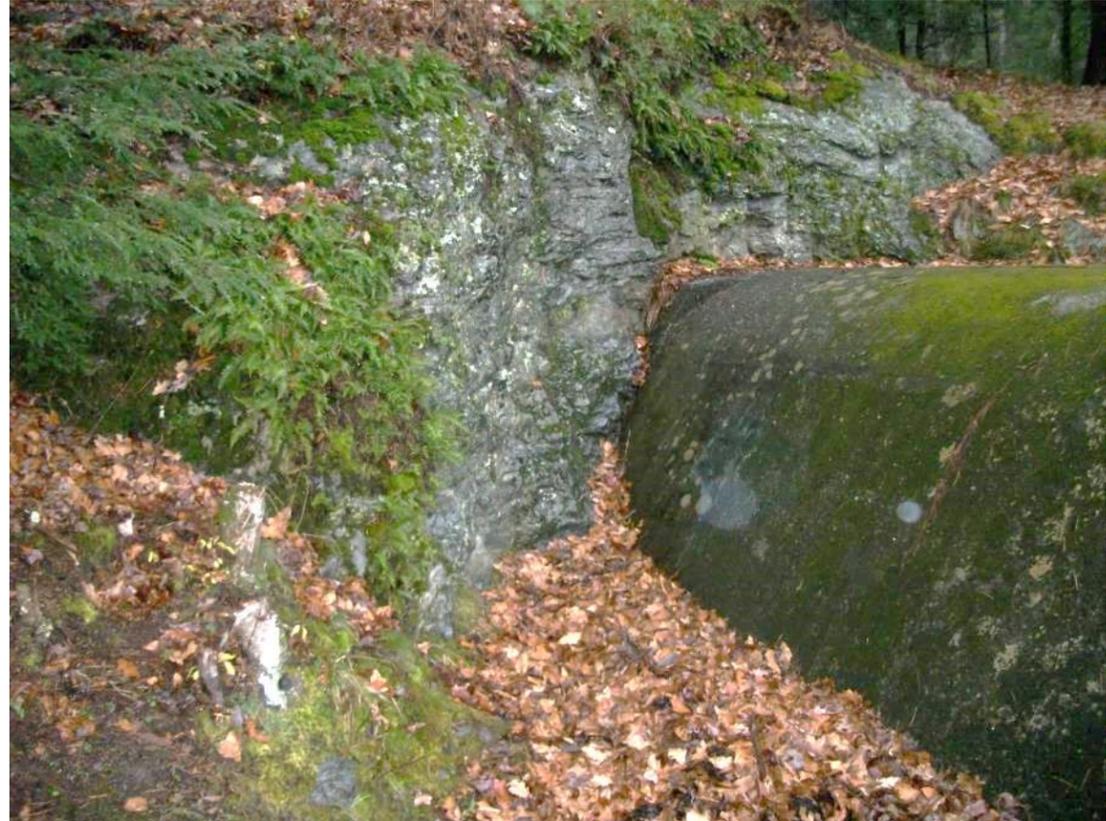
IBR-AUX-05-N-NEG SEEPAGE THROUGH THE RIGHT ABUTMENT OF THE AUXILIARY SPILLWAY

PFM Information					
Structure	Auxiliary Spillway	PFM Failure Type	Erosion/Scour	PFM Source	New
Loading Condition	Normal	Location(s)	Auxiliary Spillway	PFM Source Date	6/12/2023
PFM Description					
Flaw:	<ul style="list-style-type: none"> Construction defect exists at the right abutment (hillside) contact with the dam, due to inadequate foundation preparation. Defect allows preferential seepage along the contact, increasing the destabilizing uplift pressures. 		PFM Sketch(es)

Continuation/Progression:	<ul style="list-style-type: none"> The reservoir is at normal reservoir pool. A preferential seepage path exists through a zone of inadequate foundation preparation (such as soil-infilled rock seam) which originates in the abutment and daylight downstream of the embankment. Continued seepage along the path causes the joint to open, increasing seepage volume through the abutment. The force acting on the structure in a downstream direction exceeds the resisting load of a rock mass along the abutment.

Intervention:	<ul style="list-style-type: none"> Increasing seepage volume goes unnoticed. 				
Failure:	<ul style="list-style-type: none"> A section of the abutment rock shifts downstream. A gap is formed bypassing the dam. An uncontrolled release of the reservoir occurs. 				
PFM Disposition	<input type="checkbox"/> Ruled Out <input checked="" type="checkbox"/> Clearly Negligible <input type="checkbox"/> Asset Management <input type="checkbox"/> Insufficient Info <input type="checkbox"/> Financial/Damage State <input type="checkbox"/> Credible <input type="checkbox"/> Urgent				
Classification Justification	<p>This potential failure mode is considered Clearly Negligible. The Auxiliary Spillway has a tapering height, and is relatively short (less than 4 feet tall) at the Abutment. Historically, noticeable seepage has not been noted at the contact between the dam and the rock abutment. It is possible that increasing seepage flows could cause rock jointing in the abutment to open, destabilizing the abutment and causing isolated rock blocks to fail. However, there is currently no indication that the integrity of the hillside has been compromised. Additionally, concrete is by its nature generally resistant to erosion by low volume / low pressure water flow.</p>

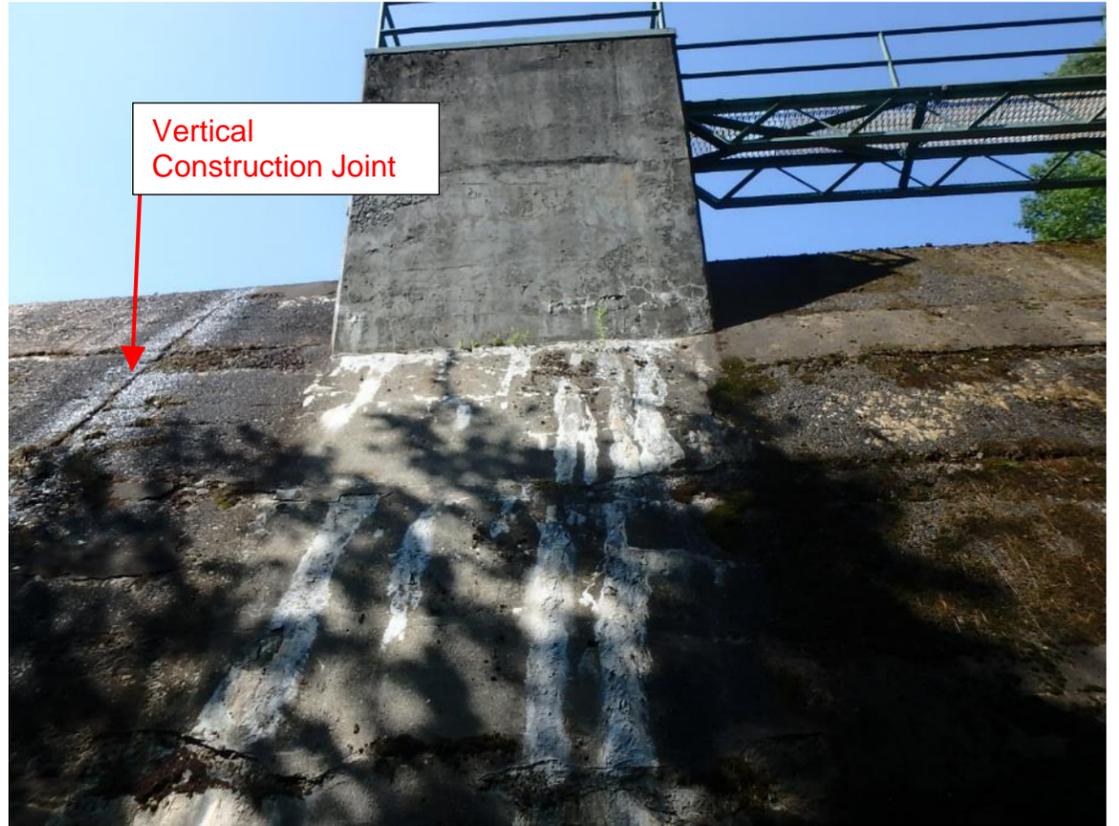
IBR-INT-02-IE-R/O SEPARATION/ROTATION OF THE INTAKE AT A CONSTRUCTION JOINT

PFM Information					
Structure	Intake	PFM Failure Type	Stability	PFM Source	New
Loading Condition	Ice, Earthquake	Location(s)	Intake	PFM Source Date	6/12/2023
PFM Description					
Flaw:	<ul style="list-style-type: none"> The Intake is essentially an empty vertical chamber in the Principal Spillway, at a construction joint. Due to the reduced vertical weight at the Intake, the concrete monolith has a reduced lateral load resistance capacity, causing the monolith to rotate downstream. 		PFM Sketch(es)

Continuation/Progression:	<ul style="list-style-type: none"> Under the theorized loading conditions [See Note 1 under Justification]. The force acting on the structure in a downstream direction exceeds the concrete-foundation interface strength locally at the location of the Intake. 				
Intervention:	<ul style="list-style-type: none"> Intervention is not successful. 				
Failure:	<ul style="list-style-type: none"> A section of the spillway rotates downstream. A gap is formed in the dam. An uncontrolled release of the reservoir occurs.

PFM Disposition	<input checked="" type="checkbox"/> Ruled Out <input type="checkbox"/> Clearly Negligible <input type="checkbox"/> Asset Management <input type="checkbox"/> Insufficient Info <input type="checkbox"/> Financial/Damage State <input type="checkbox"/> Credible <input type="checkbox"/> Urgent				
Classification Justification	<p>This potential failure mode is considered to be Ruled Out.</p> <p>It is known that the vertical weight (resisting force) of a representative cross section through the Intake is less than the adjacent portions of the Main Spillway. However, rotation and sliding of the Spillway would need to occur for a full concrete monolith. The Intake is located near to the end of the monolith (photograph to the right). For the monolith to rotate downstream, it would need to rotate about a fixed point near the abutment, overcome the shear resistance at the vertical construction joint, and essentially shear through or form a vertical full height crack along the vertical construction joint. By inspection, this is determined to not be a possible failure mechanism, and as such this PFM has been assigned a Ruled Out disposition.</p>

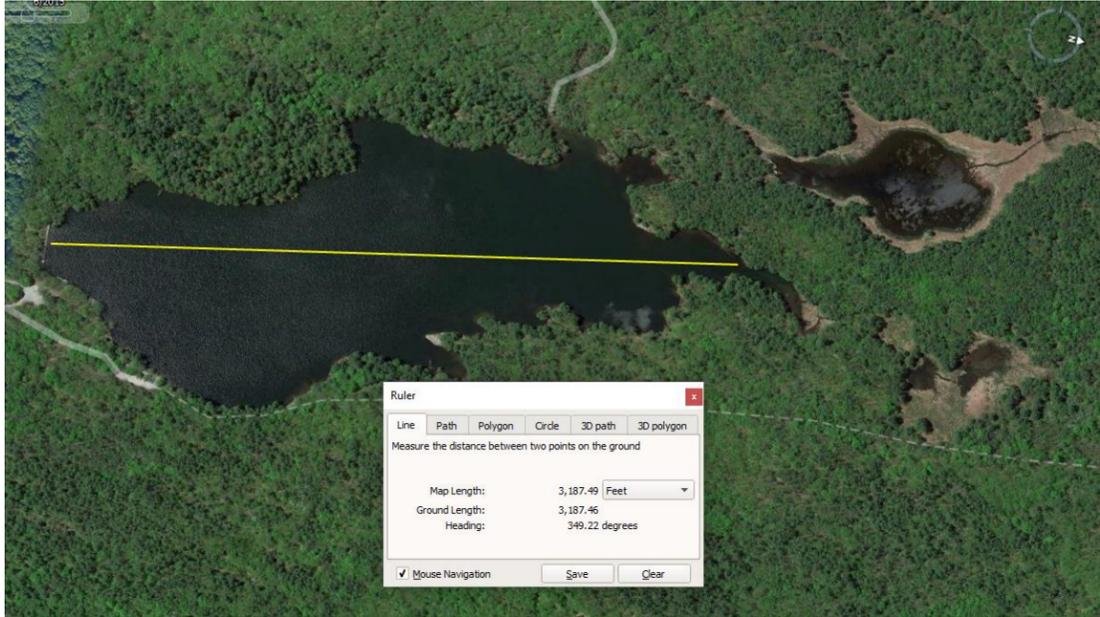
IBR-GNR-02-A-R/O FAILURE OF THE UPSTREAM BEAVER DAM CAUSES RESERVOIR SURCHARGE

PFM Information					
Structure	General	PFM Failure Type	Overtopping	PFM Source	New
Loading Condition	Normal, Earthquake	Location(s)	Main and Auxiliary Spillways	PFM Source Date	6/12/2023
PFM Description					
Flaw:	<ul style="list-style-type: none"> Beaver dam on the upstream end of the reservoir releases, allowing the impounded water to enter the Indian Brook Reservoir. Large rogue wave develops on the reservoir (from landslide, seismic event, wind gust) and overtops the Spillway. 		PFM Sketch(es)

Continuation/Progression:	<ul style="list-style-type: none"> A single, short duration wave overtops the Principal and Auxiliary Spillway. 				
Intervention:	<ul style="list-style-type: none"> n/a. 				
Failure:	<ul style="list-style-type: none"> The PFM Team could not advance this failure mode to failure. 				
PFM Disposition	<input checked="" type="checkbox"/> Ruled Out <input type="checkbox"/> Clearly Negligible <input type="checkbox"/> Asset Management <input type="checkbox"/> Insufficient Info <input type="checkbox"/> Financial/Damage State <input type="checkbox"/> Credible <input type="checkbox"/> Urgent

Classification Justification	This potential failure mode was discussed during Brainstorming, and the PFM Team agreed that it should be considered Ruled Out. There are a few small ponds at the northern end of Indian Brook Reservoir, roughly 3000 feet north of the dam. Historic beaver dam activity has created small impoundments, which are either removed by people or naturally fail. Due to the limited impoundment size, and the resiliency of concrete structures to survive single, isolated rogue waves, the PFM Team could not develop this failure mode to dam failure.				
Risk Assessment		Failure Likelihood & Life Safety Consequences			
General Discussion	The Risk Assessment did not include this PFM. Based upon its "Ruled Out" disposition, it is not considered a Risk Driver.

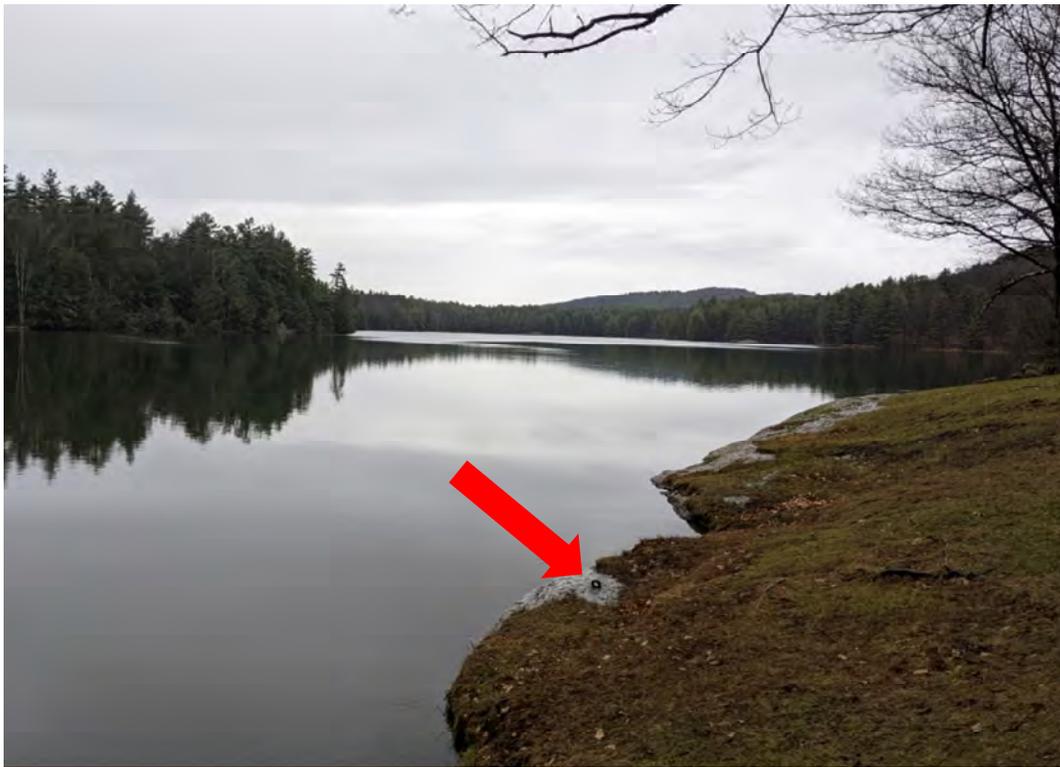
Photo 1: View of the upstream left embankment. Note anchors for buoys (red arrow) – reportedly removed from the reservoir prior to cold weather months.
