Potential Failure Mode Analysis and Risk Assessment Report

INDIAN BROOK RESERVOIR DAM NATDAM NO. VT000055

Re: Potential Failure Modes Analysis and Risk Assessment Report
Indian Brook Reservoir Dam – VT000055

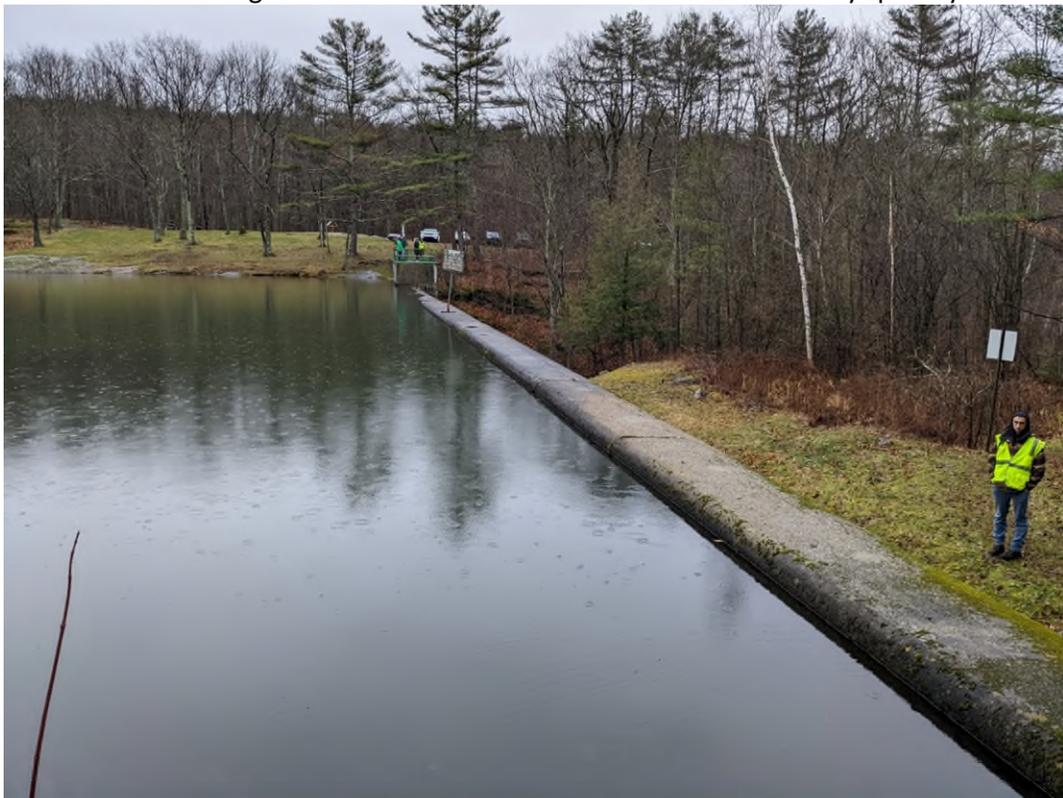
Photo 14: View of the auxiliary spillway crest and approach area. Good alignment of spillway crest.

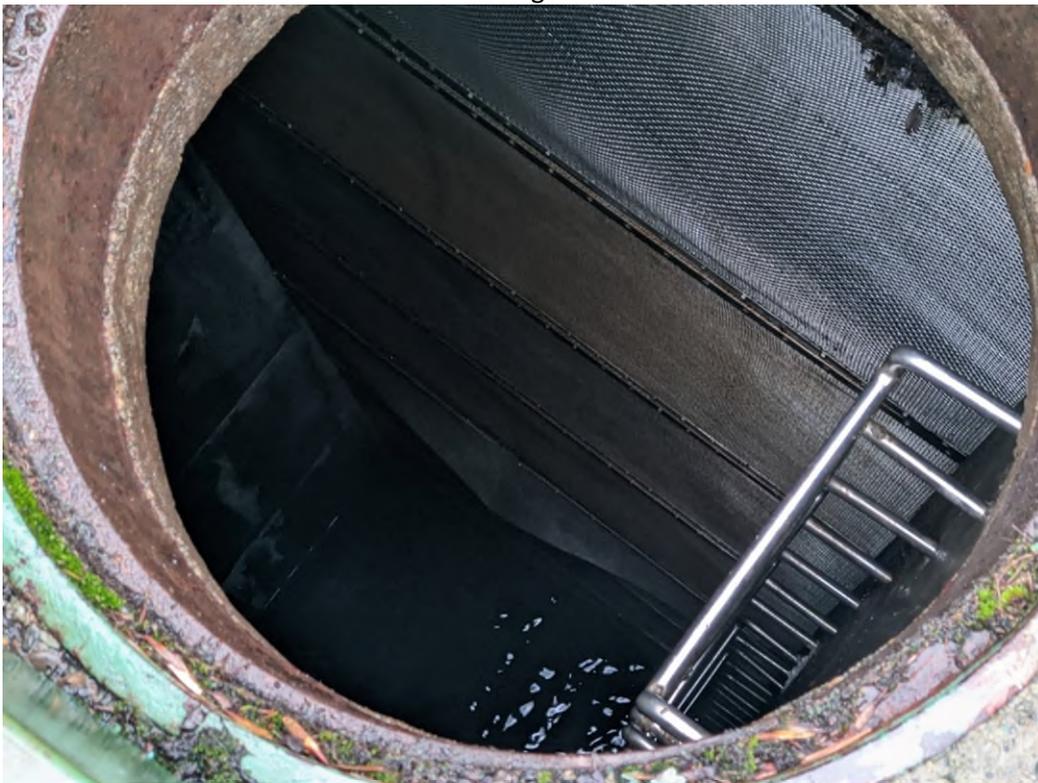
9. Intake screens are warped and bulging (See Photo No. 16).

Photo 16: View inside the gate chamber. Note warping and bulging of the lowest section of intake screen.

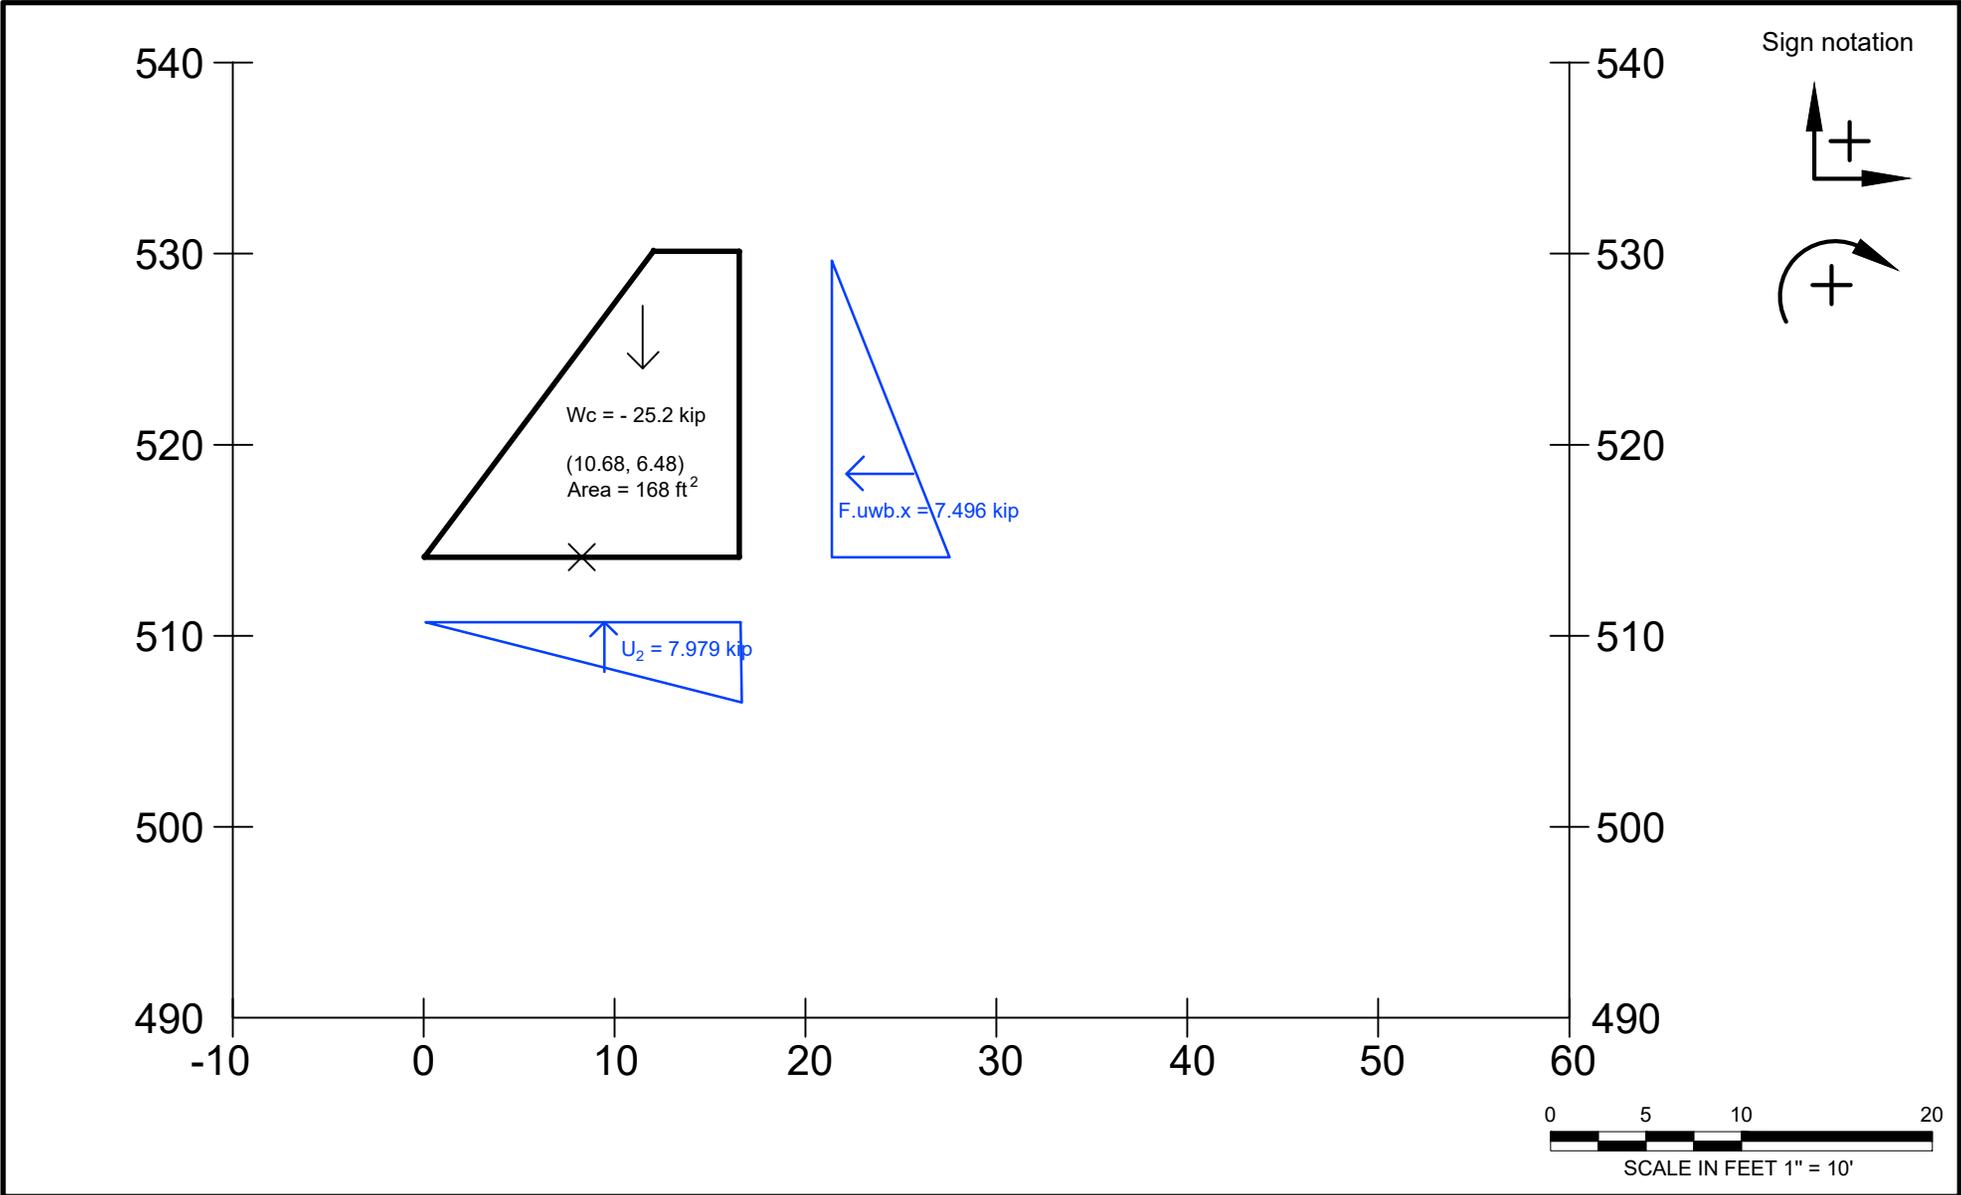
Flotation				
Case	Description	Minimum Required FS	Calculated FS	FS Flotation OK?
1	Normal water levels	1.3	3.2	OK
2	Flood water levels	1.1	2.7	OK
3	Normal water levels + Ice	1.3	2.5	OK
4	Normal water levels + Earthquake	1.1	3.2	OK

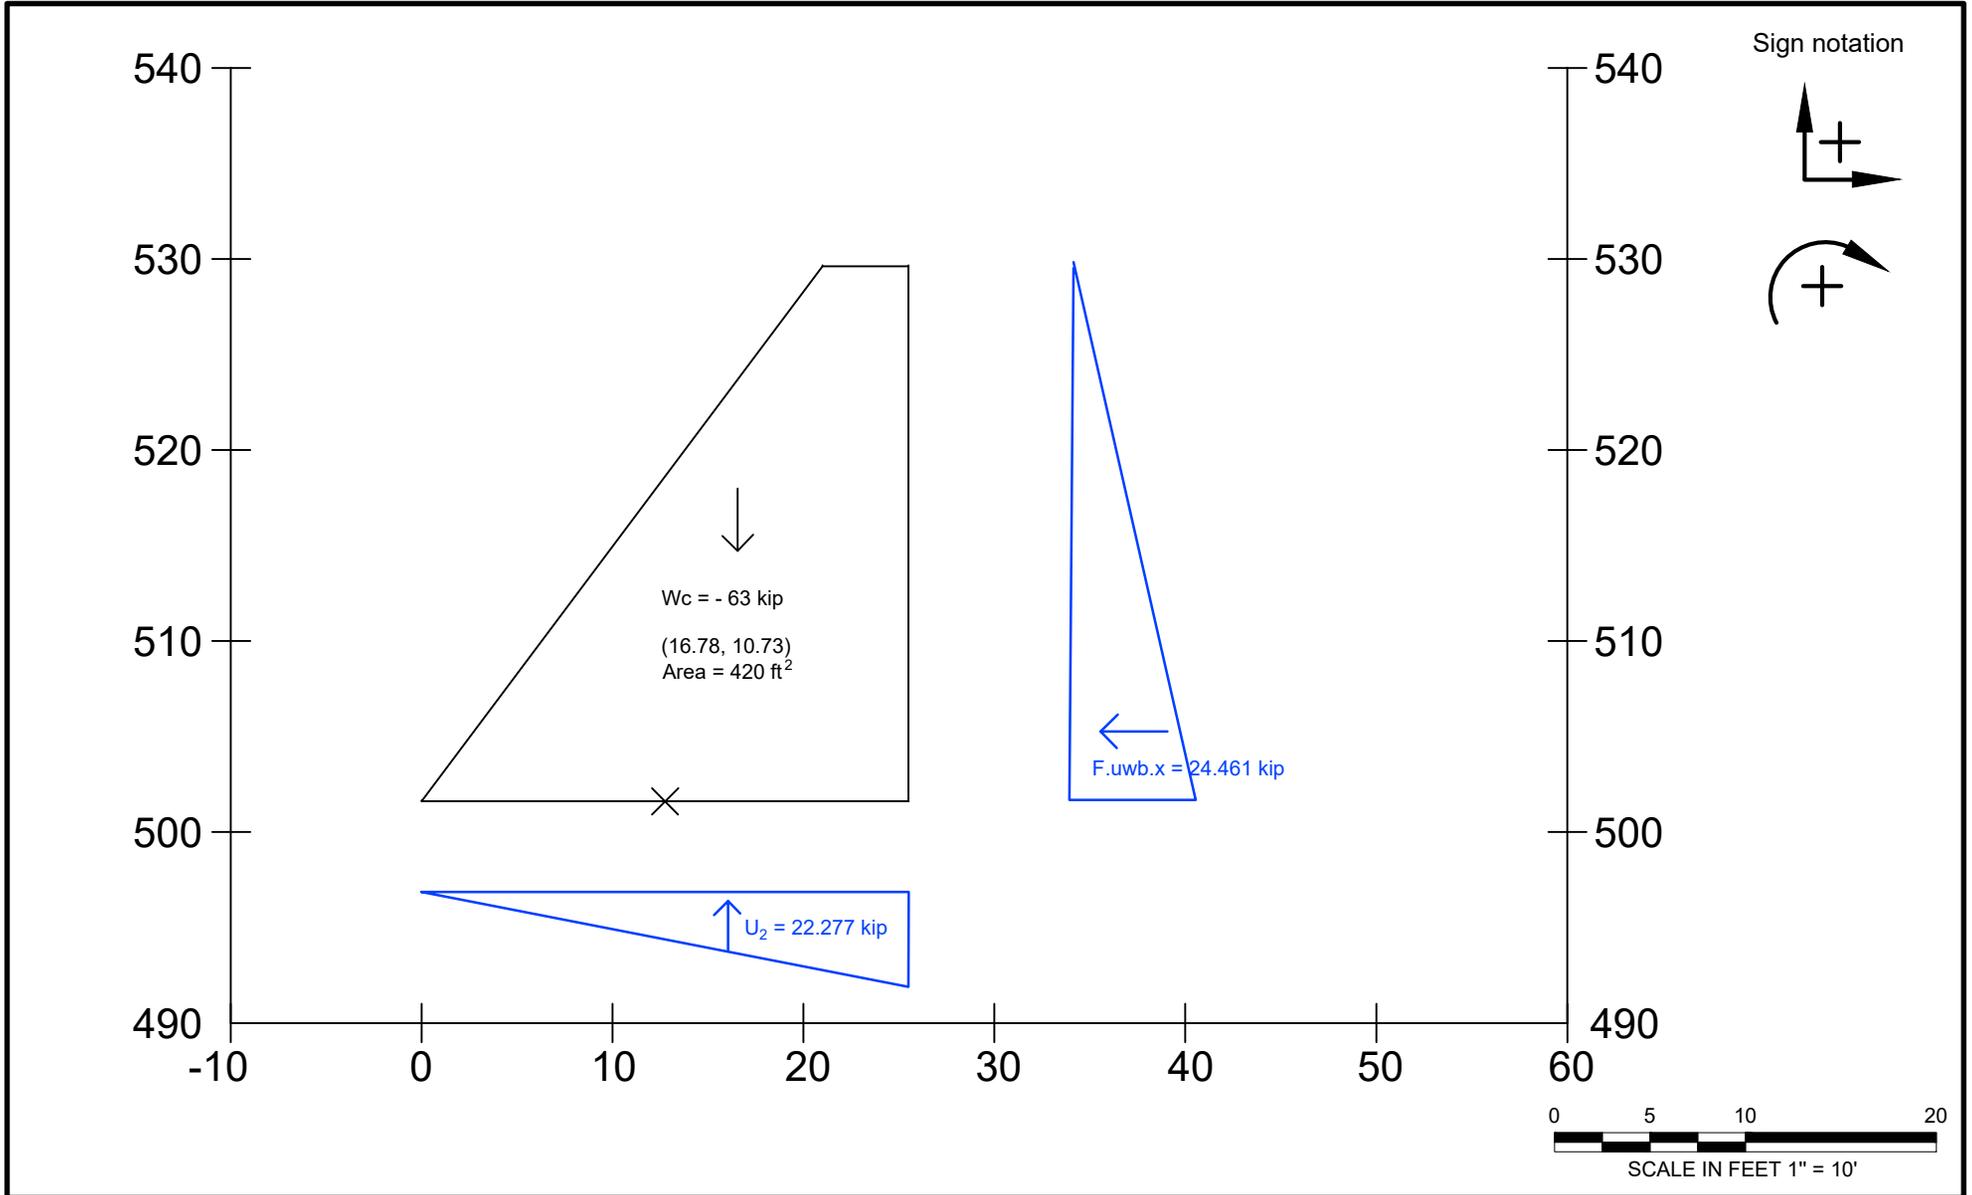
Sliding					
Case	Description	Cracked Base Analysis	Minimum Required FS	Calculated FS	Base Cohesion Req'd for Min FS (psi)
1	Normal water levels	NOT REQUIRED	2.0	1.4	4.0
2	Flood water levels	NOT REQUIRED	1.1	1.1	0.3
3	Normal water levels + Ice	REQUIRED	2.0	1.1	7.6
4	Normal water levels + Earthquake	NOT REQUIRED	1.3	0.8	5.7

Flotation				
Case	Description	Minimum Required FS	Calculated FS	FS Flotation OK?
1	Normal water levels	1.3	2.8	OK
2	Flood water levels	1.1	2.3	OK
3	Normal water levels + Ice	1.3	2.5	OK
4	Normal water levels + Earthquake	1.1	2.8	OK

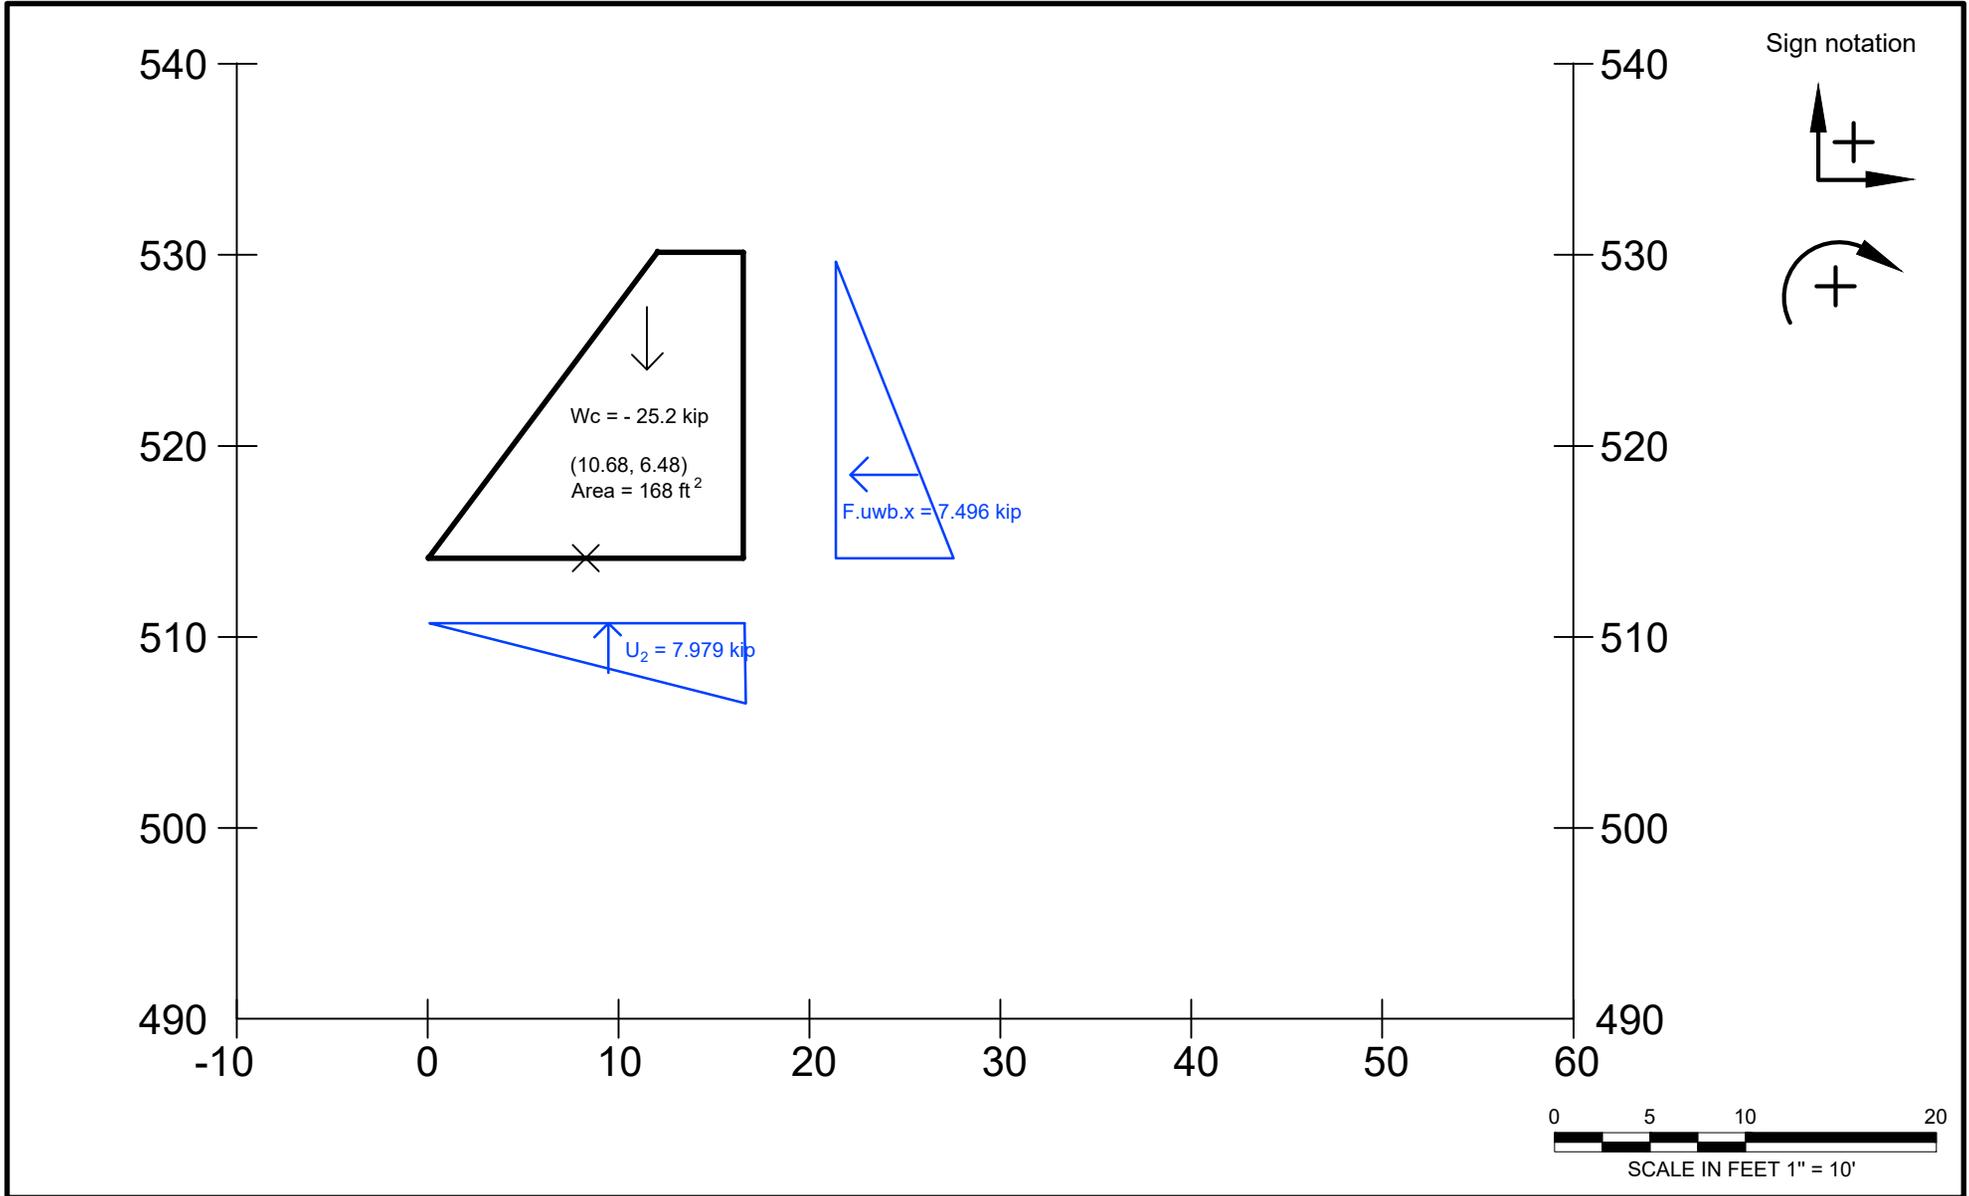
Flotation				
Case	Description	Minimum Required FS	Calculated FS	FS Flotation OK?
1	Normal water levels	1.3	3.2	OK
2	Flood water levels	1.1	2.7	OK
3	Normal water levels + Ice	1.3	2.5	OK
4	Normal water levels + Earthquake	1.1	3.2	OK
